Spilsby Theatre, Spilsby, Lincolnshire. Structural Overview **November 3, 2017**

1. Introduction

Condition Survey Facade

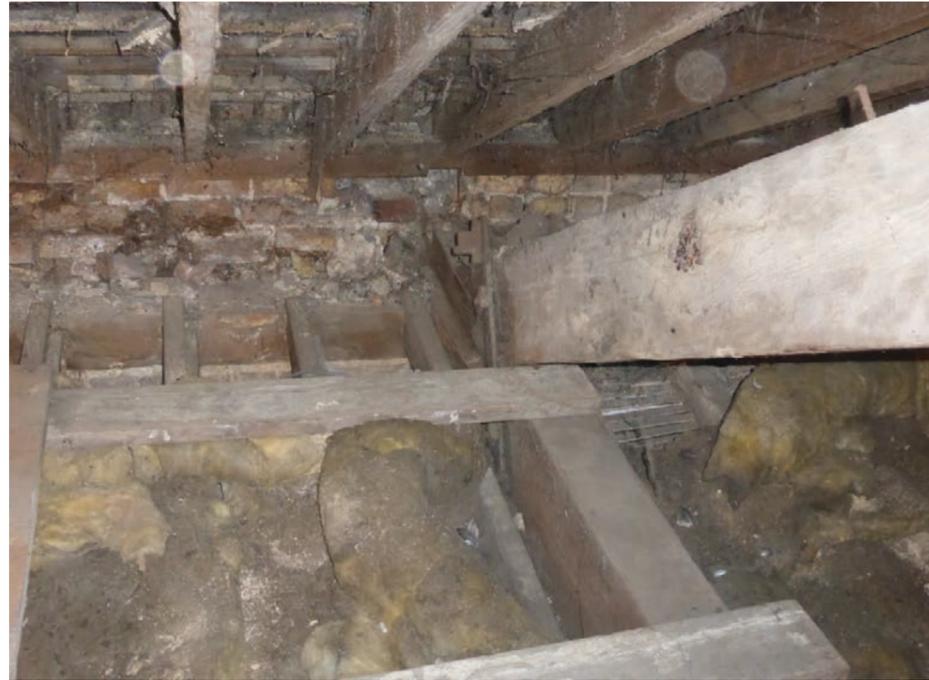
Photo 1. King Post Truss T1, East end, failure of bottom boom which has dropped partly through ceiling and pushed brick wall out of plumb.

taking off the slate, it will be easier to jack up the 2 failed trusses, fit new steelwork strengthening, and rebuild the section of leaning wall.

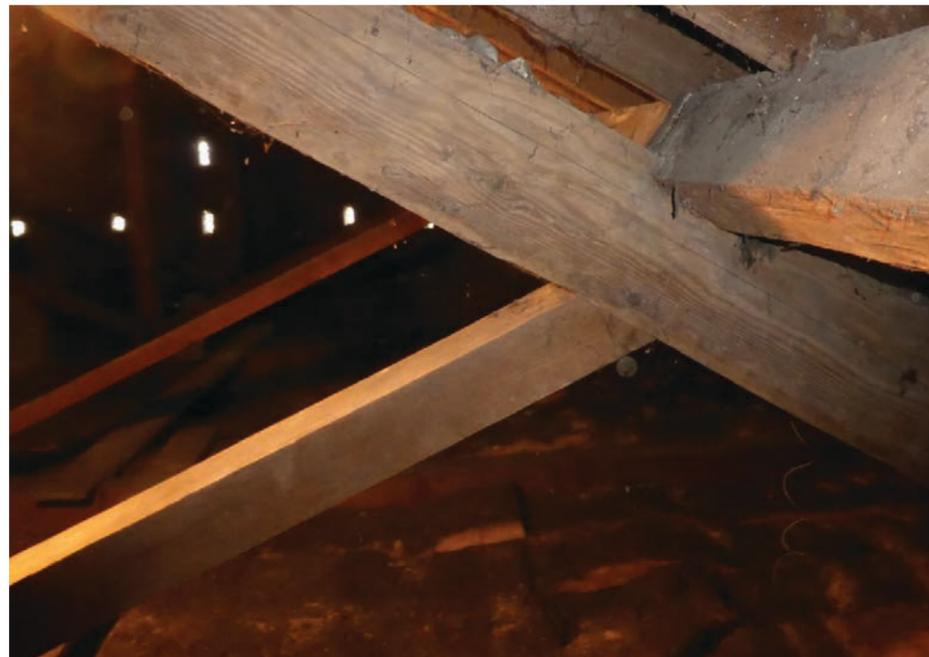
Photo 2. Truss T1 has dropped approx. 75mm at the purlin, so the purlin is no longer adequately supported. This has caused the roof to drop and push outwards, causing the East wall to lean out of plumb.

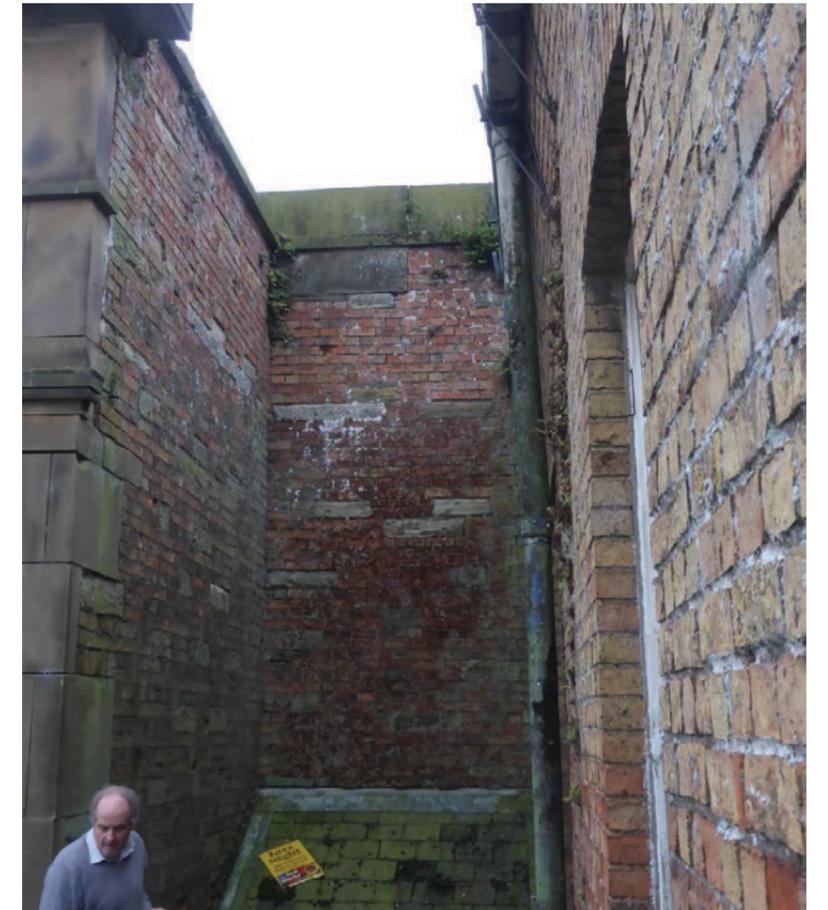
- b) On the East wall of the Courtroom just below gutter, the top of the wall has been pushed out of plumb because of the failing timber king post trusses T1 and T2 (see photo 3). This section of wall, about 6m long and 0.7m high, just below the gutter will have to be rebuilt when the truss ends are repaired (as described in Parag 2)

Photo 3. Top of East Wall out of plumb caused by fractured trusses T1 T2.

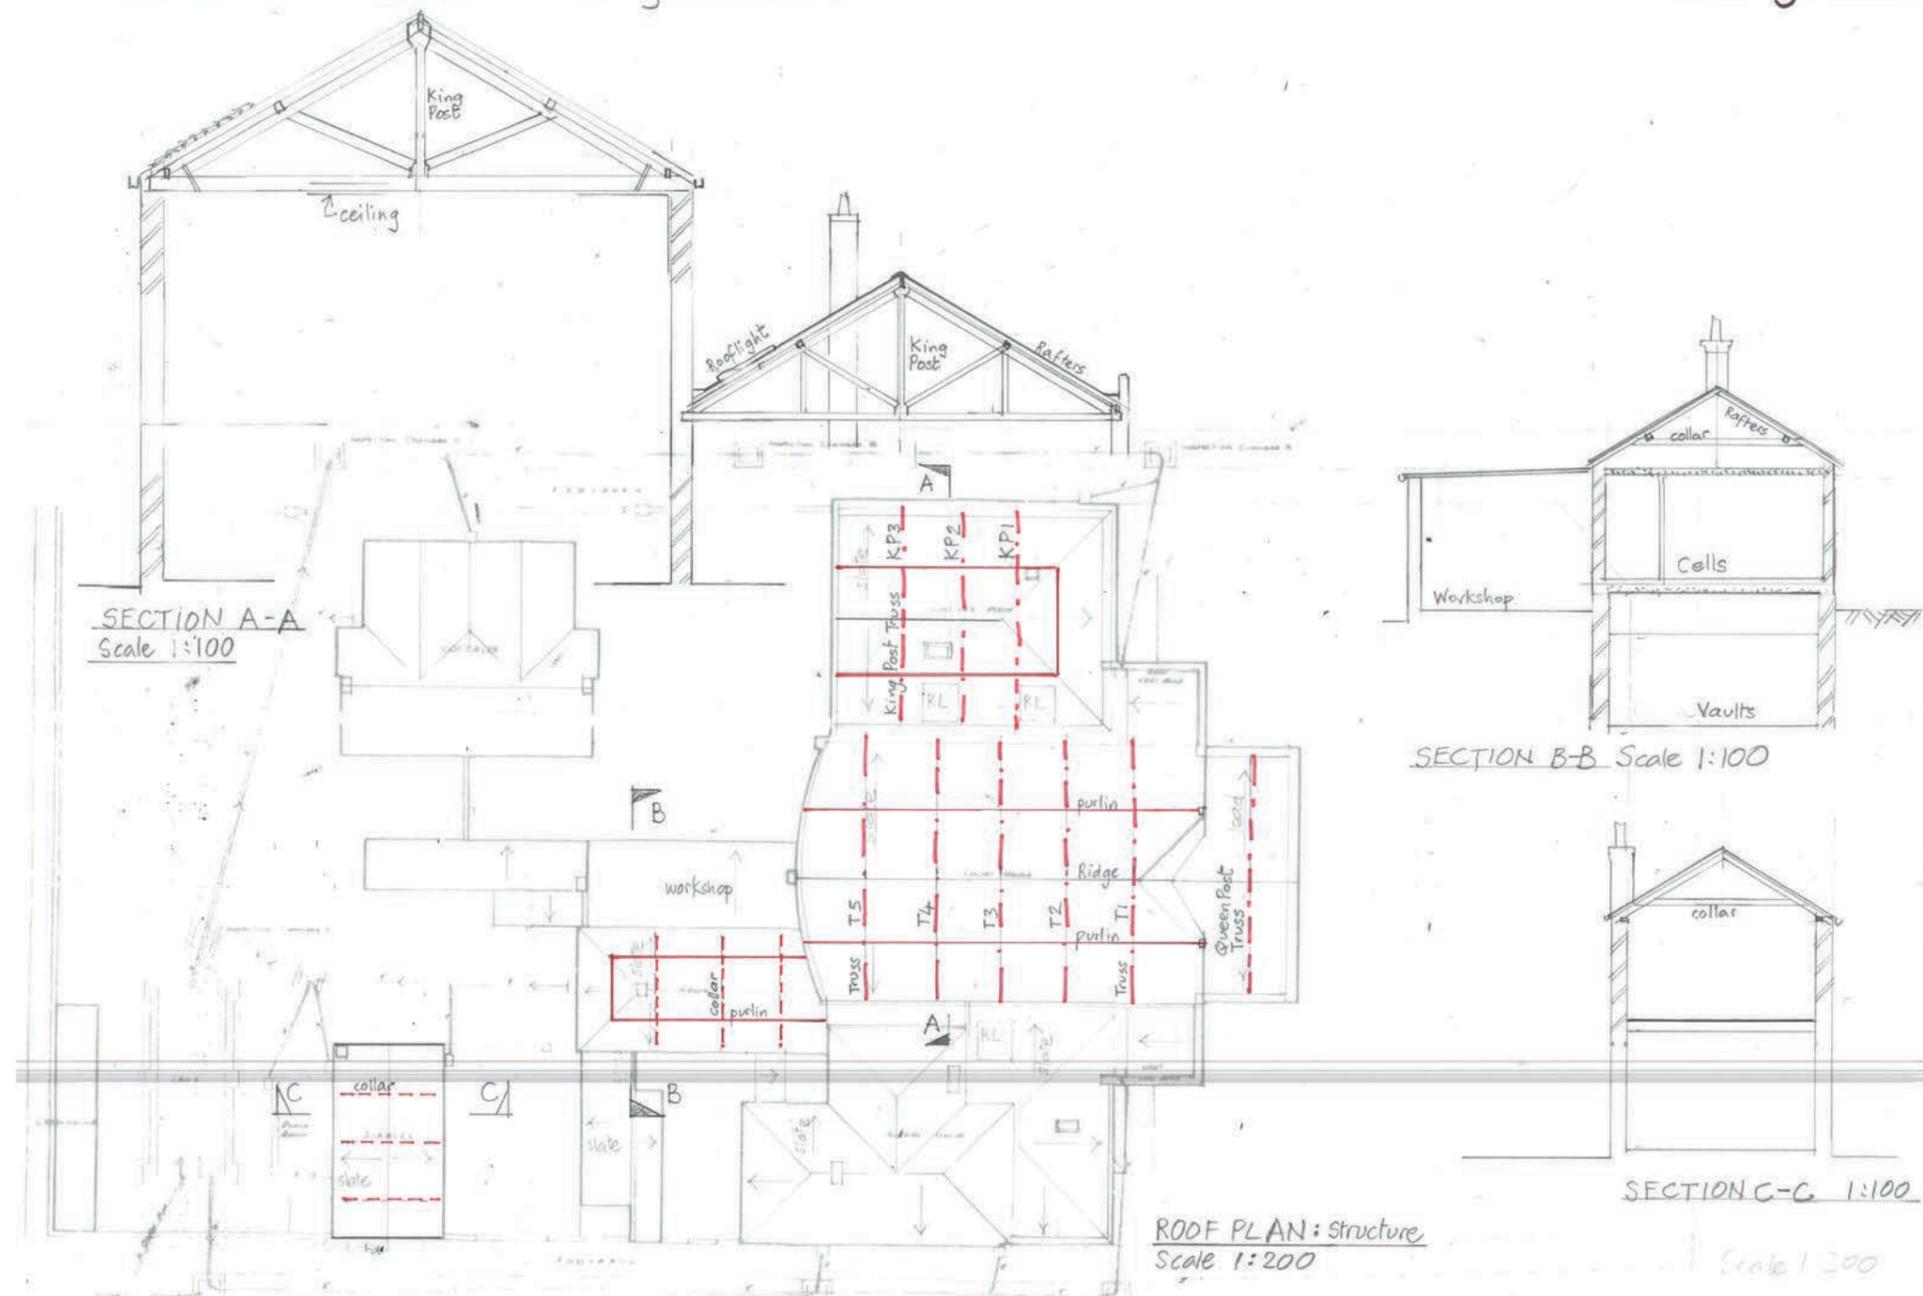
Drawing 3.

Common Rafter
have dropped ~150
and spread outwards
which has caused
crack in brickwork.

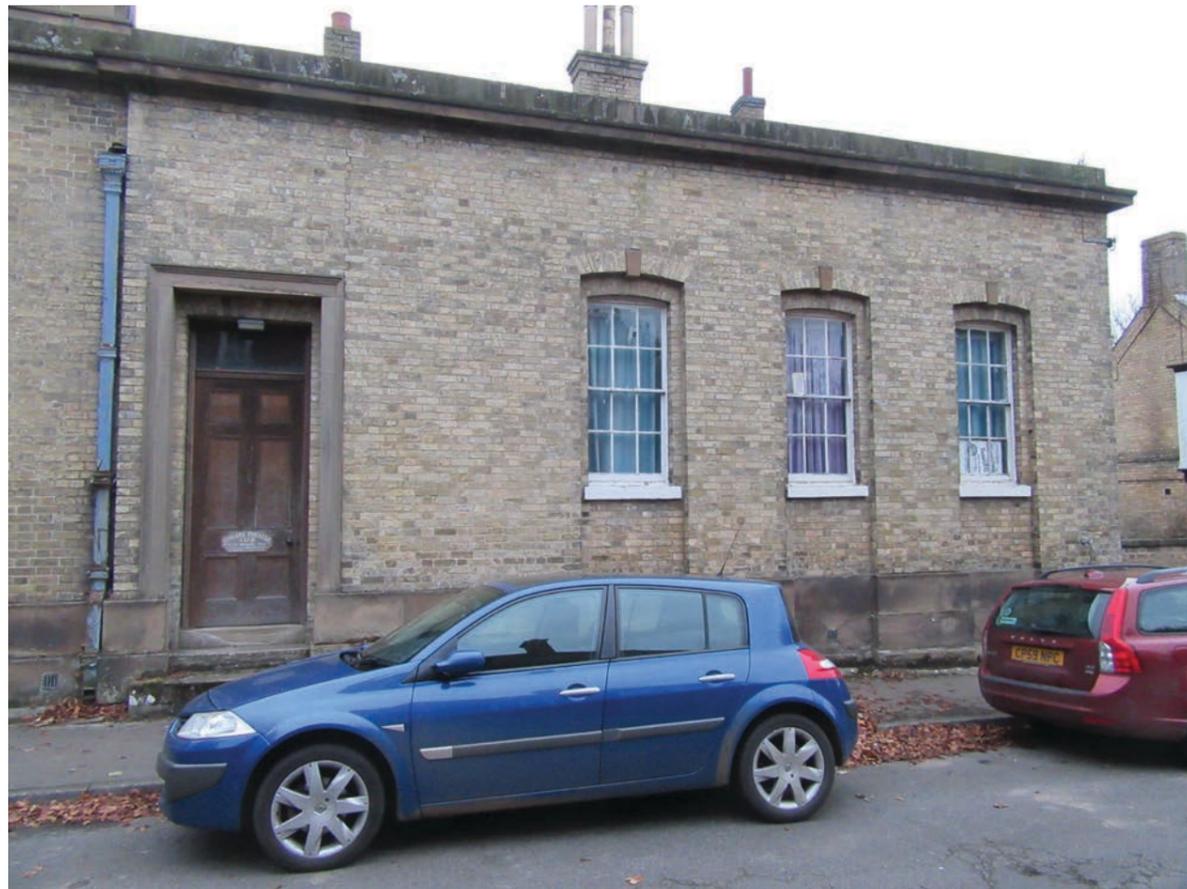
2.1

Detail of the door and plinth: staining and mild spalling from rising damp; missing pointing. Rainwater goods in need of refurbishment or replacement.

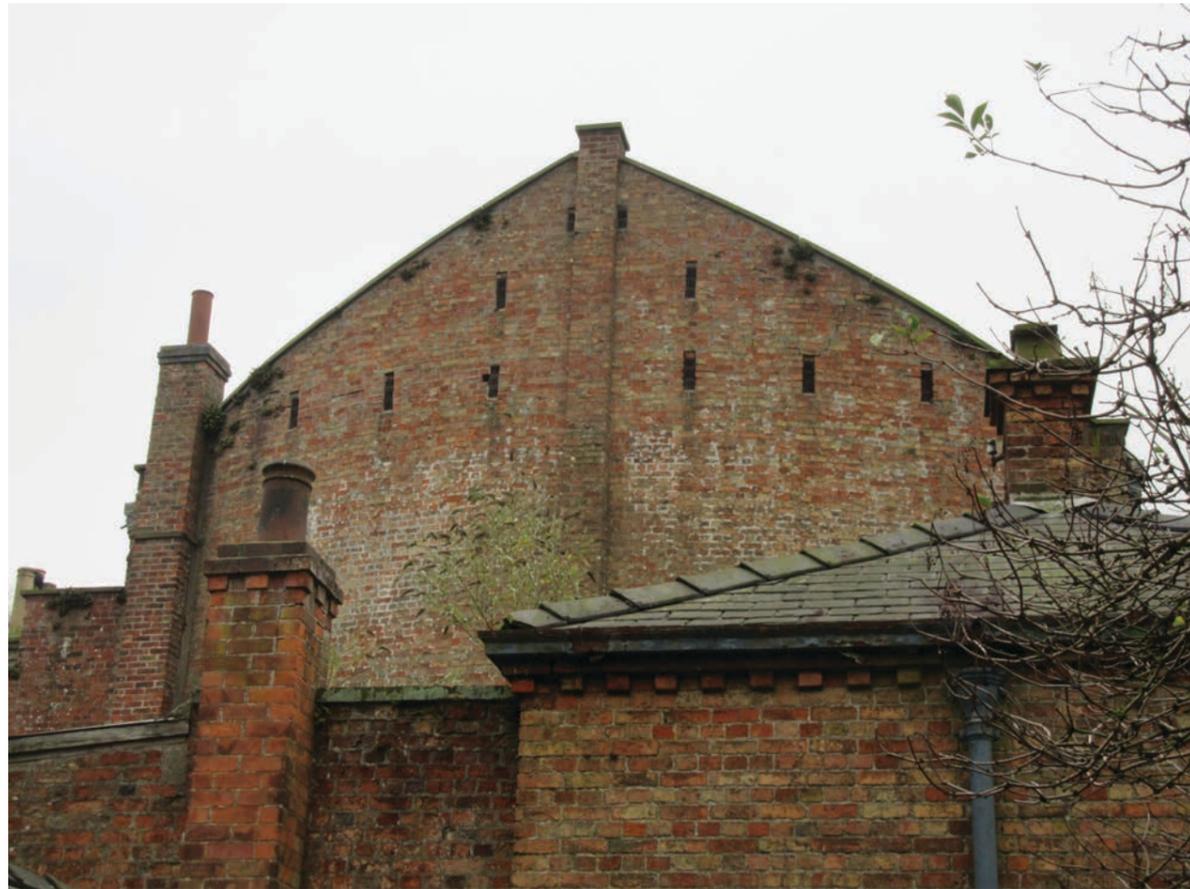
3.1

North wall of the courtroom: the brick and brickwork are in good condition with only localised repointing needed.

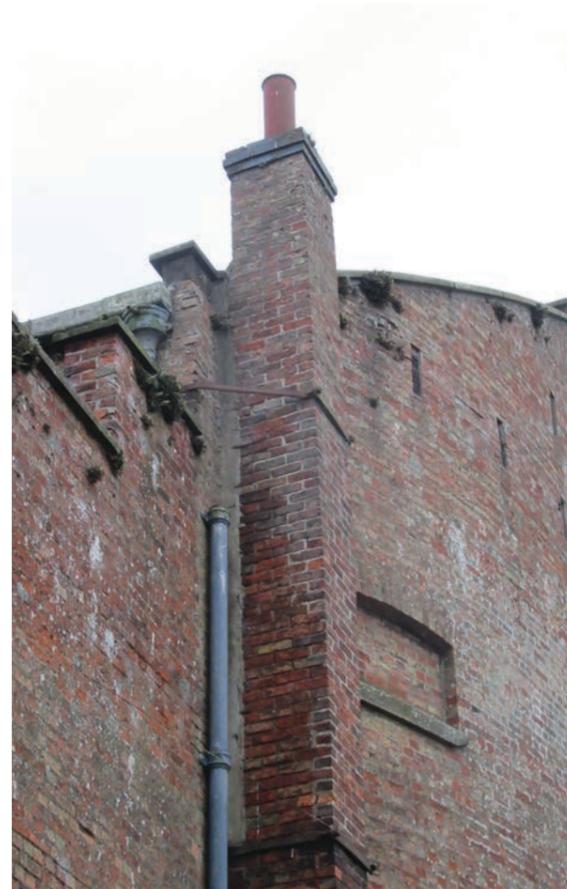
3.2

Detail of the north wall of the courtroom. Pointing is deteriorated or missing from the copings and vegetation has started to take root in open joints.

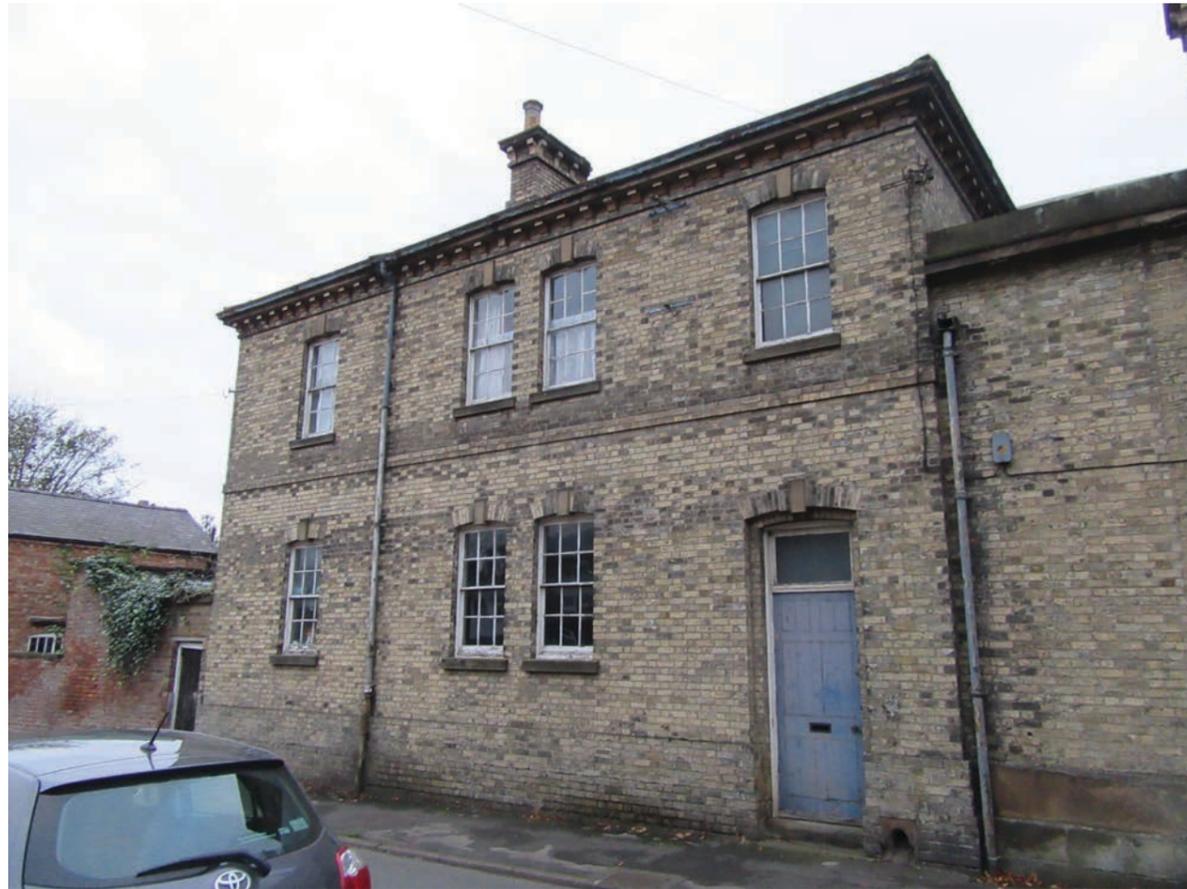
4.1
The police house dates from the 1870s. As elsewhere, it is well built with no signs of structural problems. Brickwork is in good condition with only localised repointing needed. The joint between the 1820s and 1870s brickwork can be seen at the far right of the photo. There are no stone dressings or plinths.

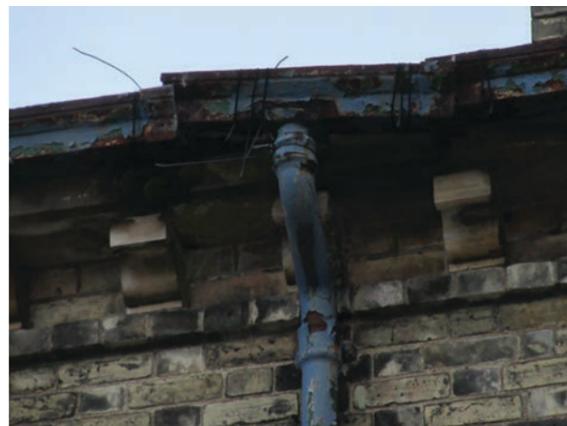
4.3
Gutters and downpipes are likely to have been in service for 140 years, without much attention, and may yet only need refurbishment rather than full replacement.

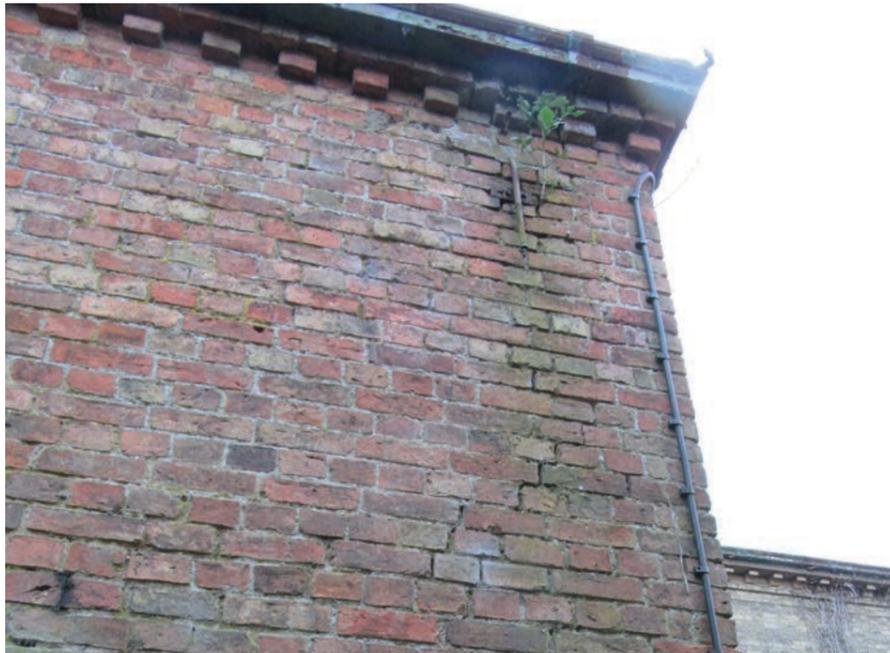
6.1

Cell block north wall: missing downpipe and erosion of pointing.

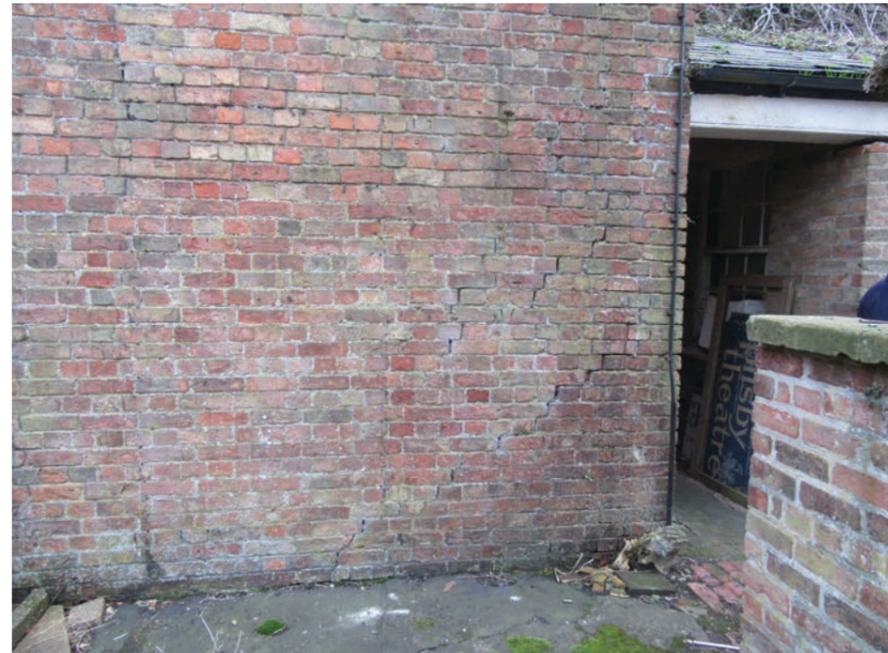
6.2

Movement and cracking in the north-west corner of the cell block. The stump or the drain to the bottom-right of the photo suggests the cause.

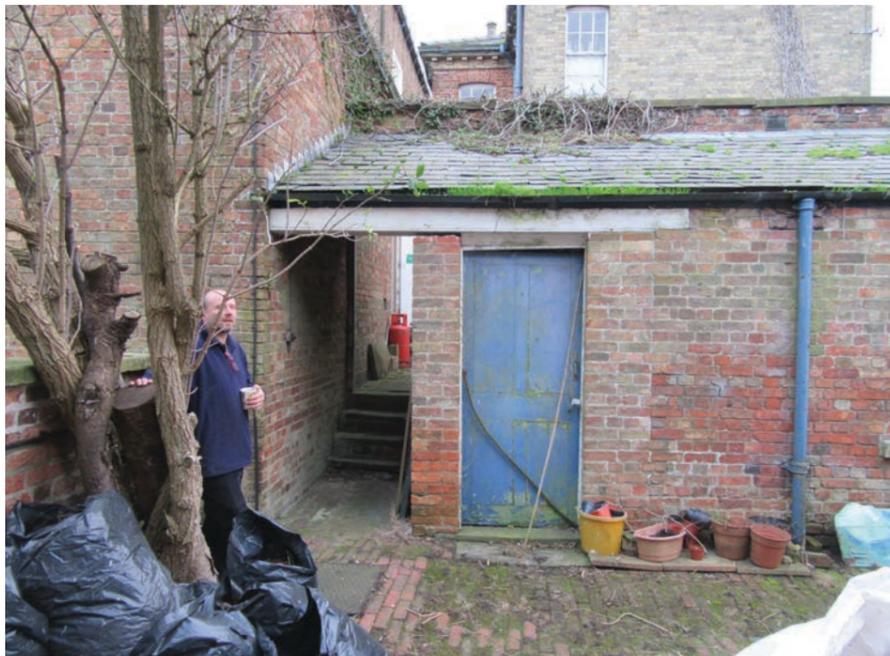
6.3

Brickwork under the white-painted beam looks to be a later in-fill which was not well founded and has moved.

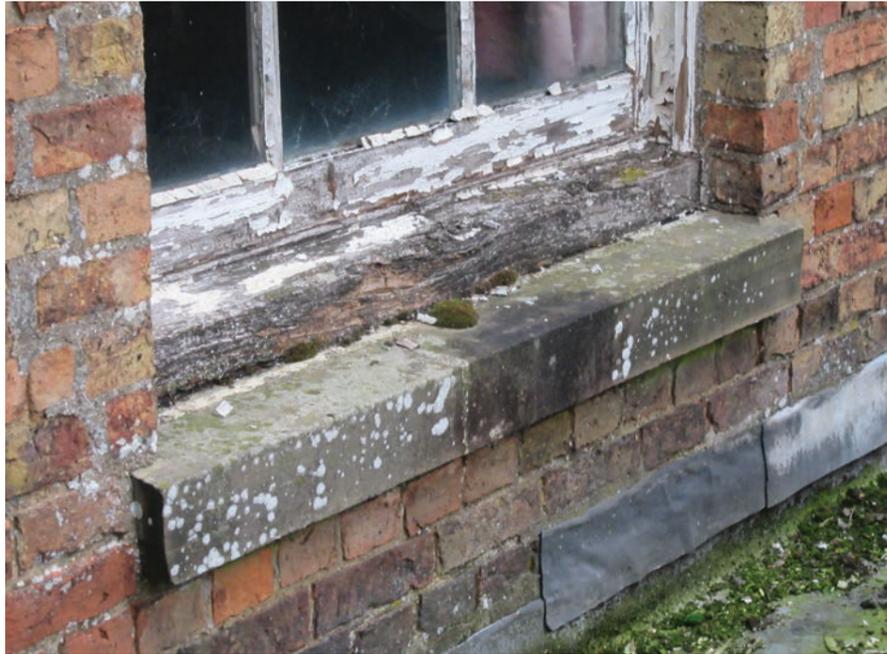
7.5
Windows generally, and particularly at high level to the courtroom, as this photo, need reglazing, new cills and repairs to sashes, glazing bars and frames.

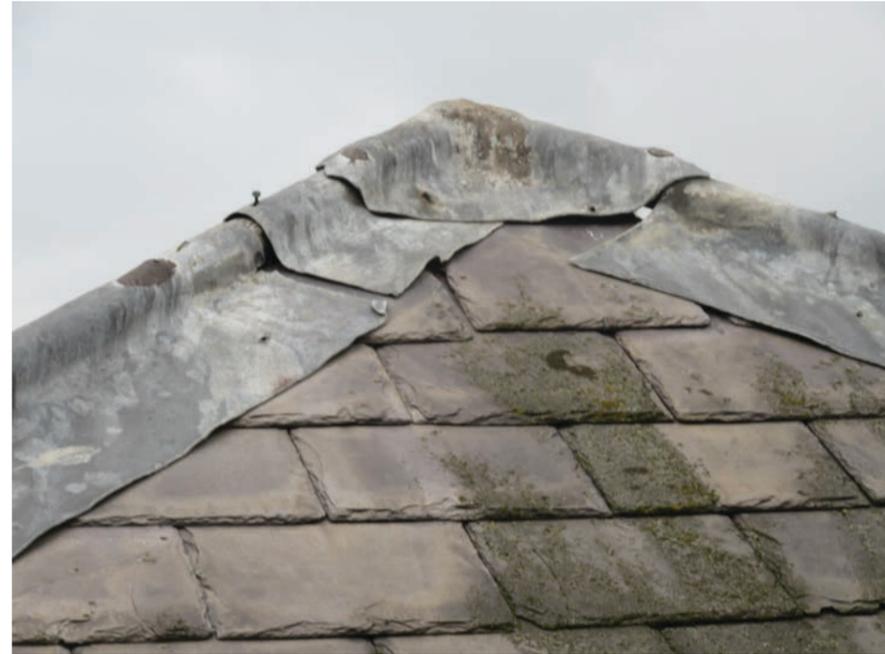
7.6
Temporary patch-ups have a habit of staying for the long-term.

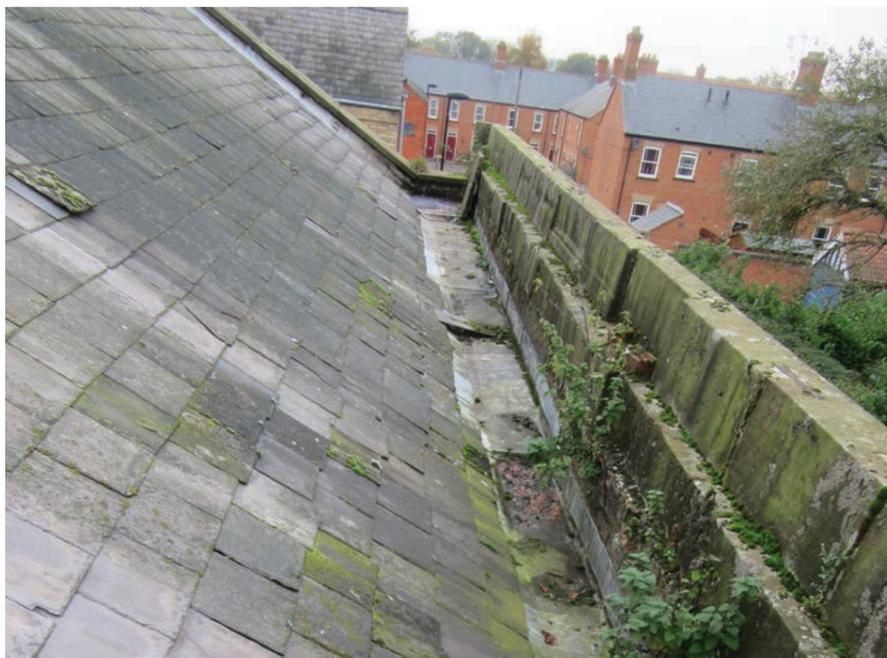
7.7
Typical condition of parapet gutters. Alongside renewal of lead and pointing, thought should be given to a slim and discrete handrail to give safe access for clearing the gutters.

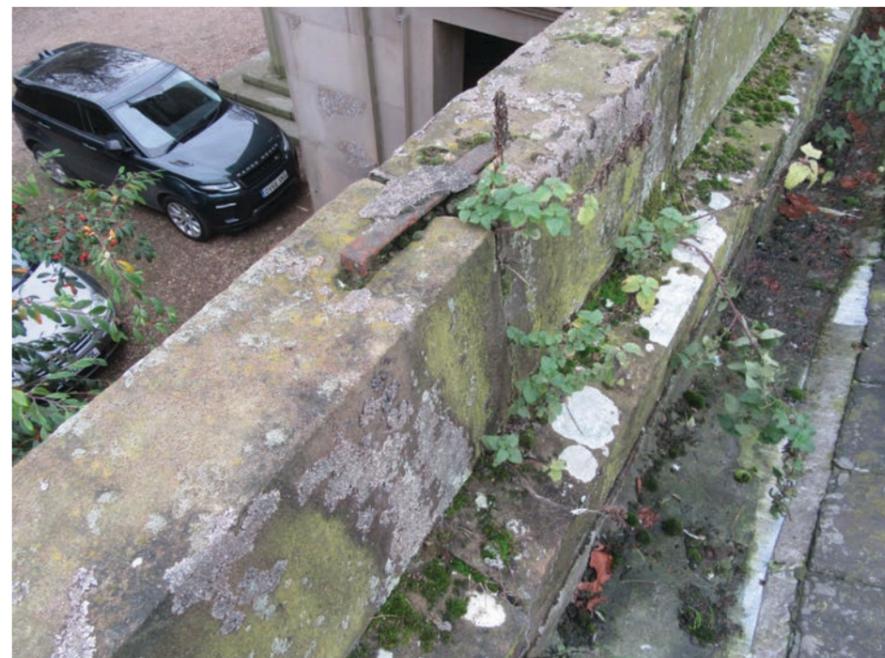
7.8
The iron cramps joining the parapet stones are corroding but have not yet damaged the stones. These should be cut out and replaced with stainless steel set into hot lead. Alternatively, lead wrapping to the parapets might be considered, but the risk of theft and the cost of replacement of extensive areas of lead should be accounted for at these more accessible levels.

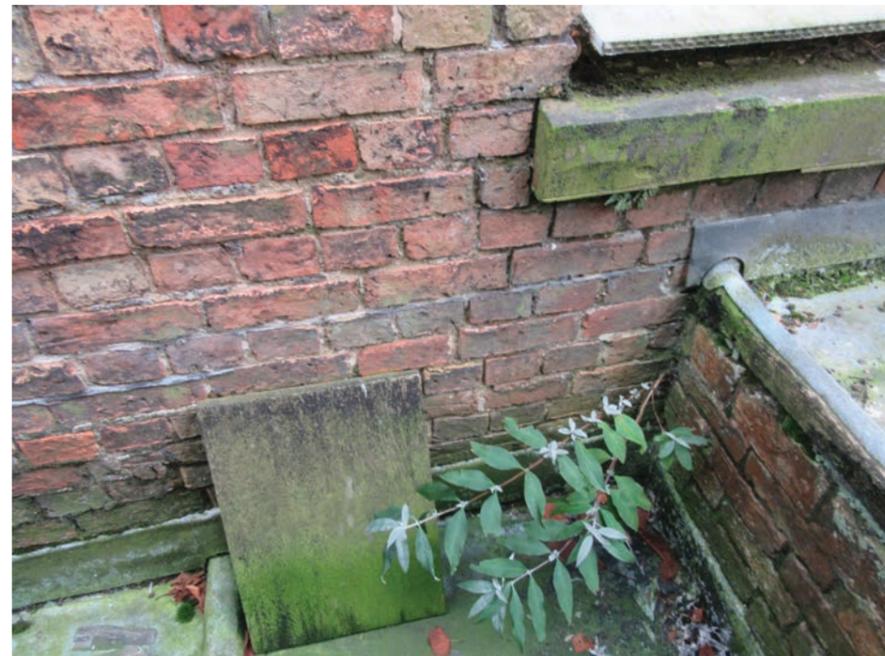
7.12

Missing lead has caused deterioration of the brickwork and vegetation growth.

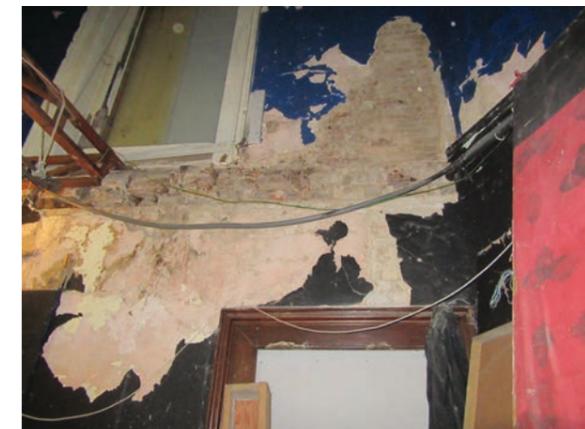
10.5

Damage to finishes at points of water ingress.

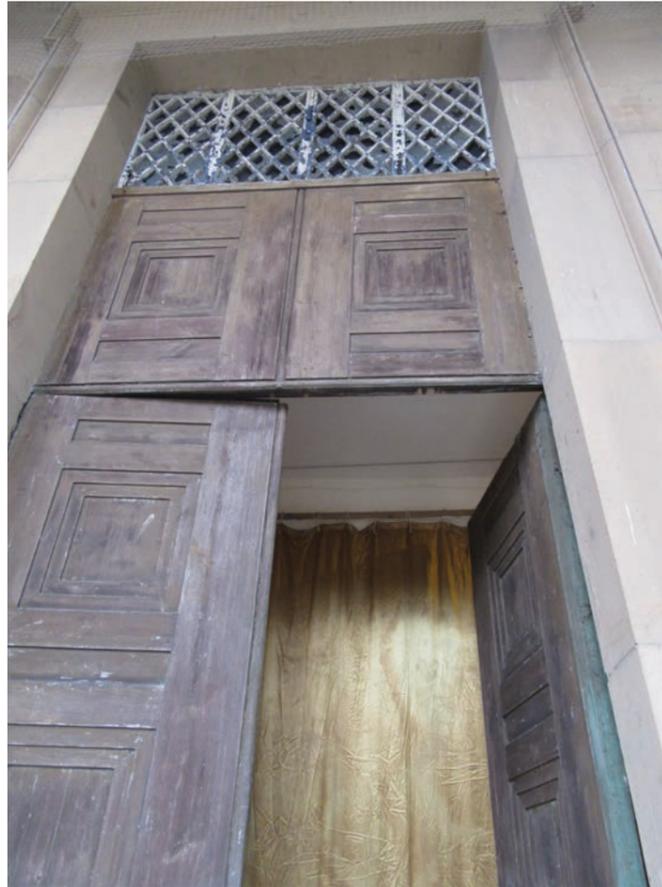
11.1
The portico door is so substantial as to be beyond deterioration and is only in need of cosmetic attention. Ironmongery is complete and operable.

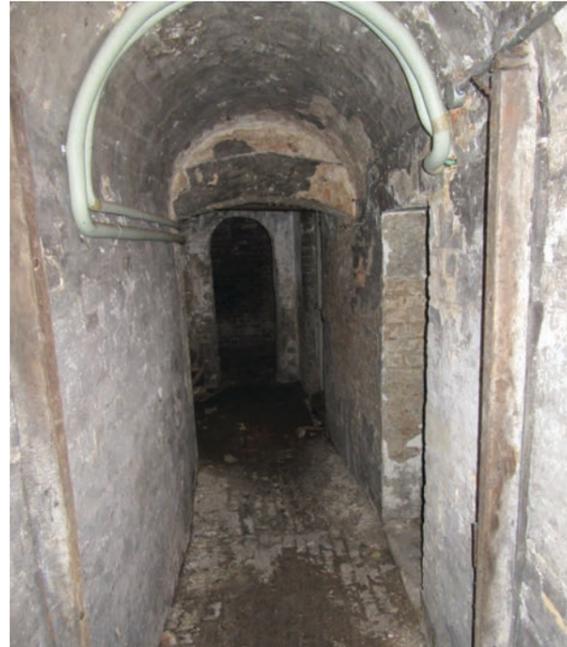
11.2
Underground prisoner's tunnel: There are no signs of structural problems. Surfaces are a little damp but there are no indications of substantial water ingress. Attempts to waterproof the area would be costly and destructive of the wonderful atmosphere. Keeping the area well ventilated is more appropriate.

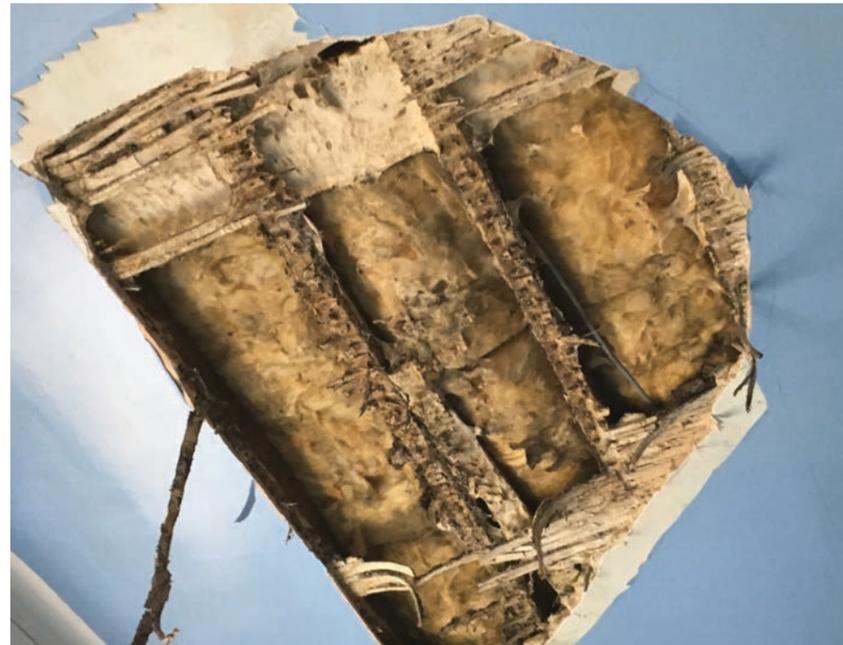
The partial collapse of two of the main trusses in the courtroom is a serious problem, preventing the use of this space by the public. However the more immediate problem, and the one with the potential to cause more widespread damage is the condition of the roofs. These are letting in water in a number places, which will cause cumulative damage to wooden structures and internal finishes. Photo 14.1 shows a recent collapsed portion of the ceiling of magistrate's room. Wet plaster gains weight considerably, and wet rot can be seen on the ceiling laths, not visible from the loft space through the mineral wool. The room is now out of use.
