Spilsby Sessions House Viability Study

Architectural Report
Updated June 2022

Introduction

ROOF STRUCTURE Structural Survey Nov 3 2017

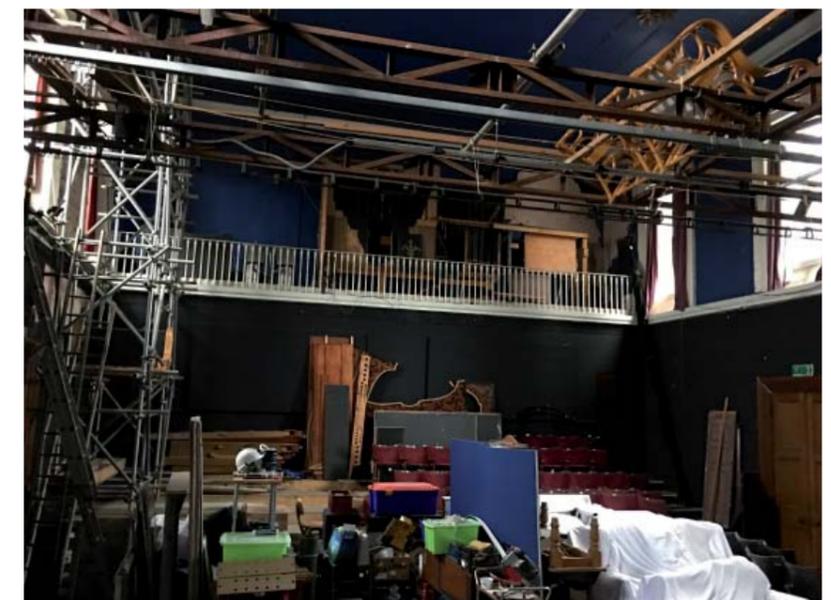
courtroom; the scaffold to the left is currently supporting two failed main roof trusses

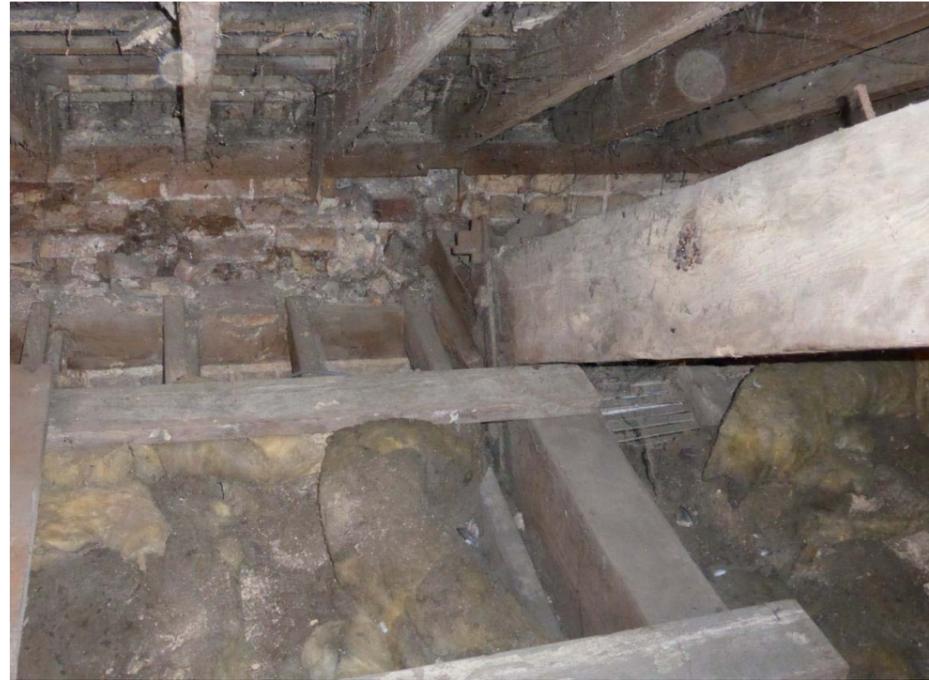
Two of the main trusses (T1 and T2, near the Portico) have suffered decay at the East end, and the bottom booms have fractured next the supporting wall. This has happened because the bearing position of the principal rafter is not over the wall - rather it falls short, and puts bending stress into the bottom boom of the truss. These trusses now sag, and this has pushed the top part of the East wall out of plumb, (see photos 1, 2 and 3, and drawing 4). The sagging has fractured the ceiling. These 2 trusses, now propped on temporary scaffolding, need to be repaired probably using new timber and steel plates spliced onto the existing timber. The trusses will need to be jacked up, in order to restore their position above the lathe and plaster ceiling. This work will mean taking off the slates, but since some of the slates are showing signs of delamination and there is no sarking felt, it will be desirable to renew the slates and leadwork. Because all the trusses are weak at their ends, it will be necessary to strengthen both ends of all 5 trusses by adding steel shoes hidden in the roof space (see drawing 4). It will also be necessary to look at the bearing ends of all other trusses, some of which were hidden from view.

Photo 1. King Post Truss T1, East end, failure of bottom boom which has dropped partly through ceiling and pushed brick wall out of plumb.

taking off the slate, it will be easier to jack up the 2 failed trusses, fit new steelwork strengthening, and rebuild the section of leaning wall.

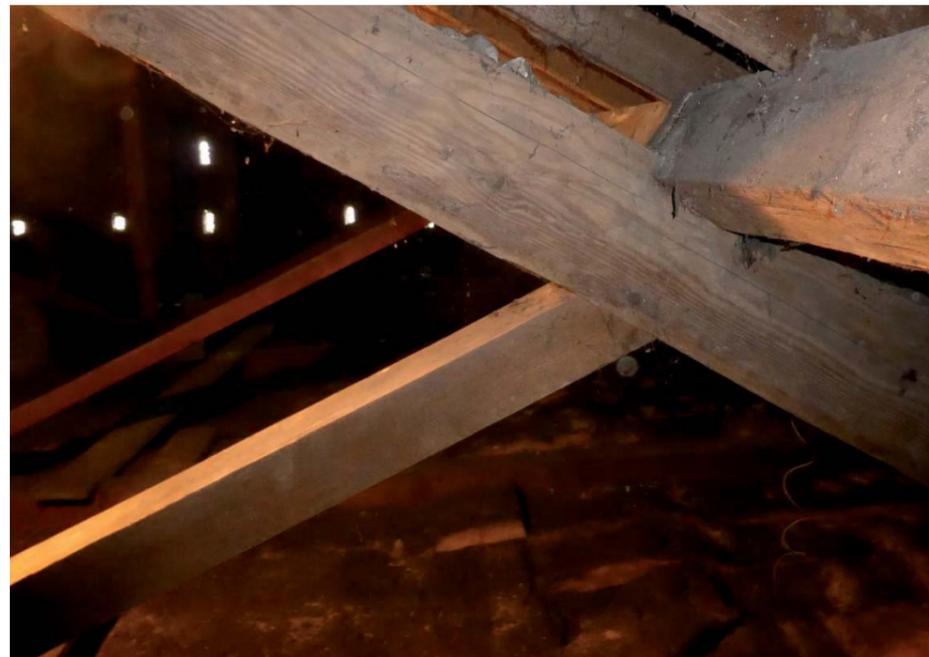
Photo 2. Truss T1 has dropped approx. 75mm at the purlin, so the purlin is no longer adequately supported. This has caused the roof to drop and push outwards, causing the East wall to lean out of plumb.

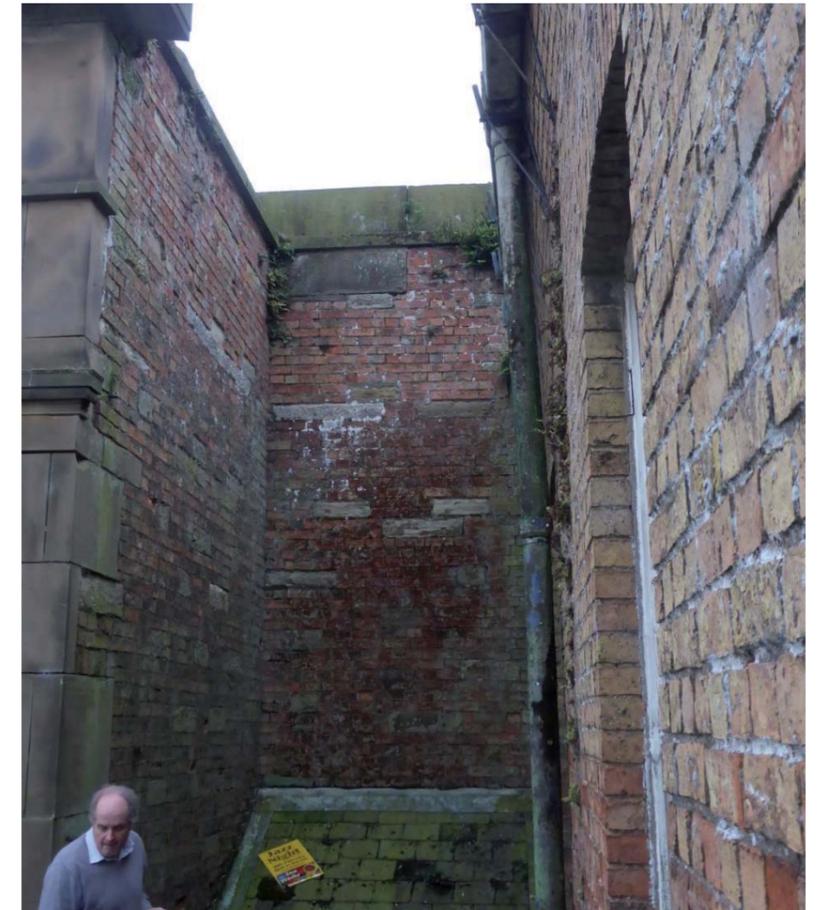
- b) On the East wall of the Courtroom just below gutter, the top of the wall has been pushed out of plumb because of the failing timber king post trusses T1 and T2 (see photo 3). This section of wall, about 6m long and 0.7m high, just below the gutter will have to be rebuilt when the truss ends are repaired (as described in Parag 2)

Photo 3. Top of East Wall out of plumb caused by fractured trusses T1 T2.

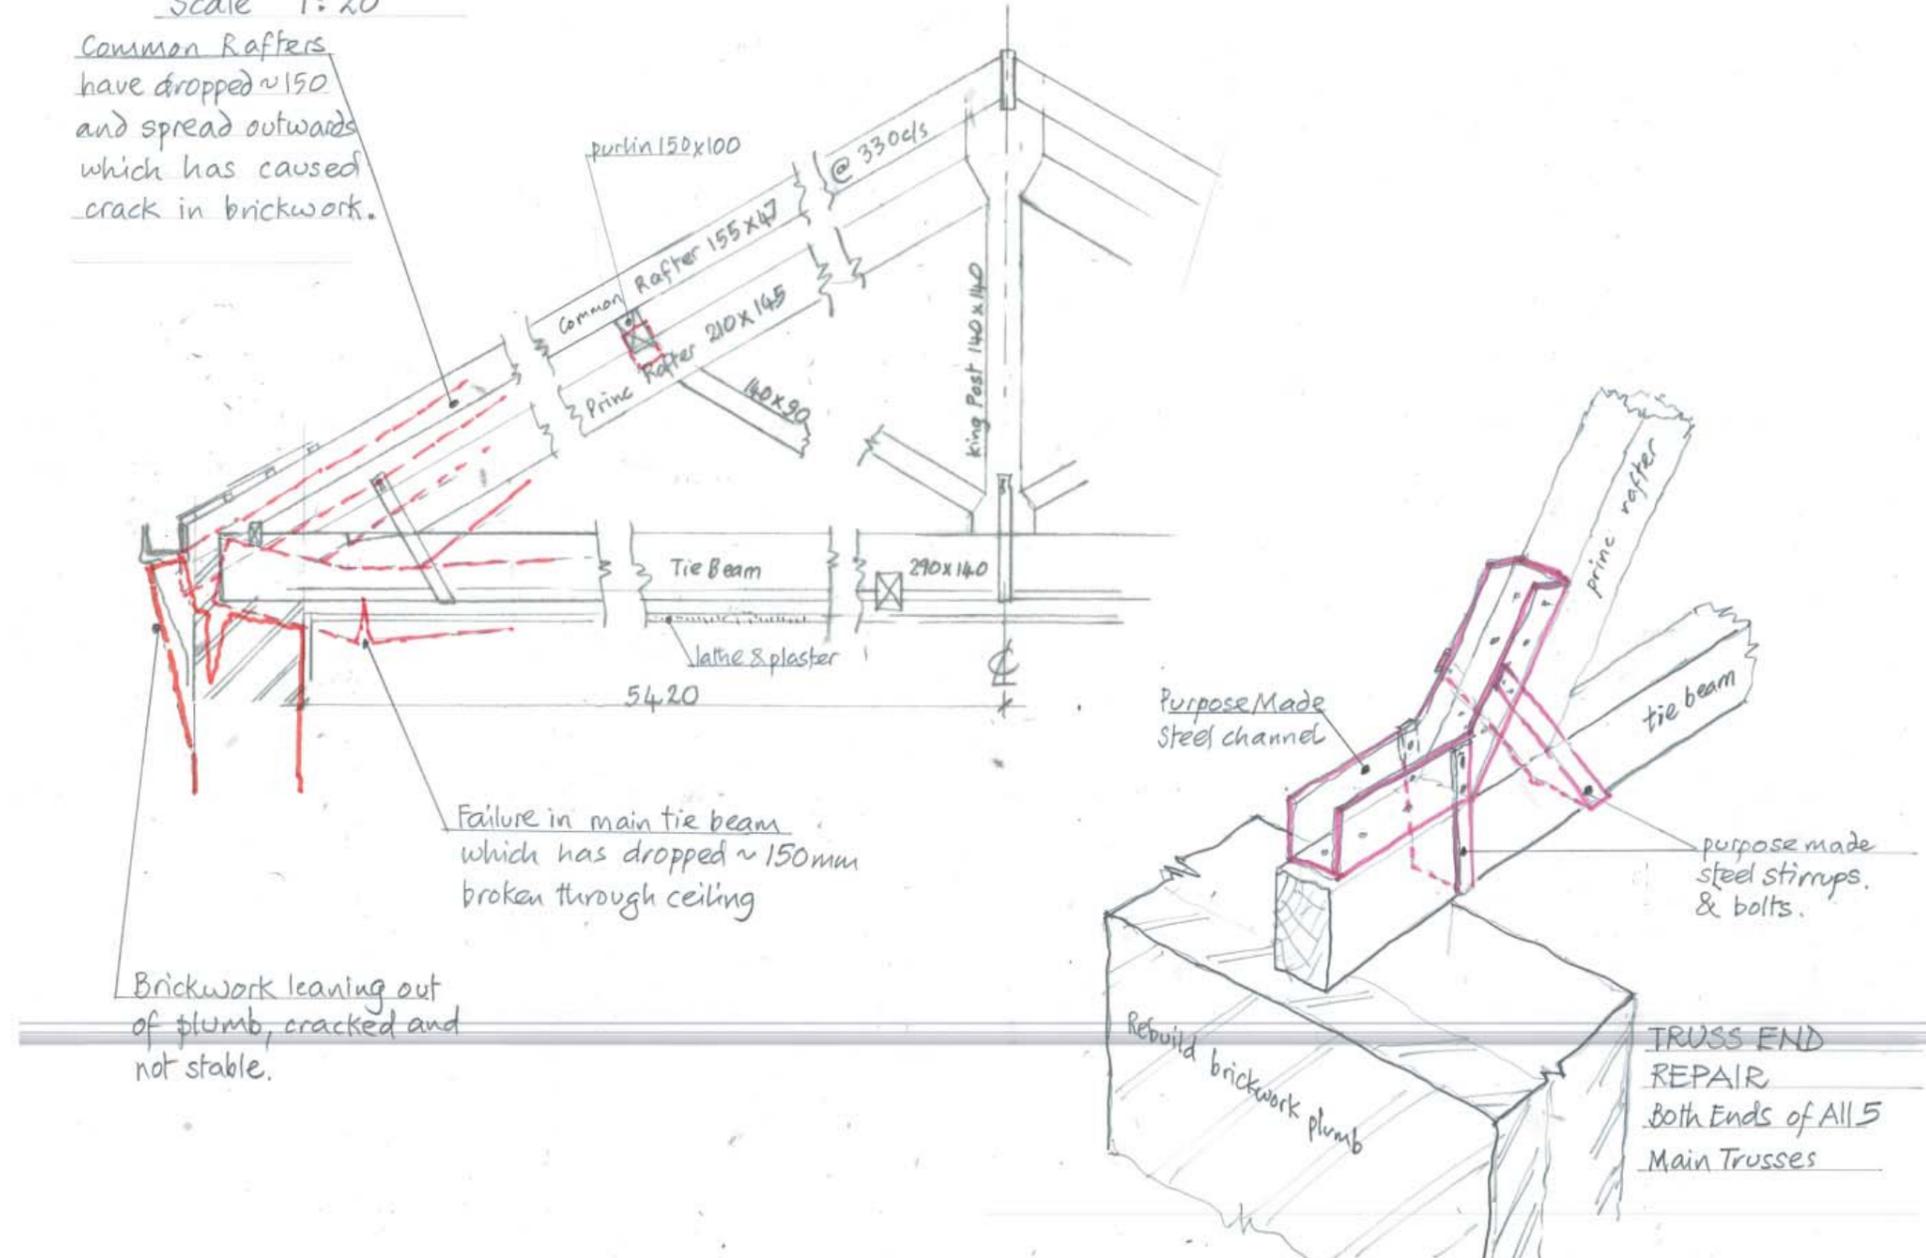
Drawing 4.

Common Rafters have dropped ~150 and spread outwards which has caused crack in brickwork.

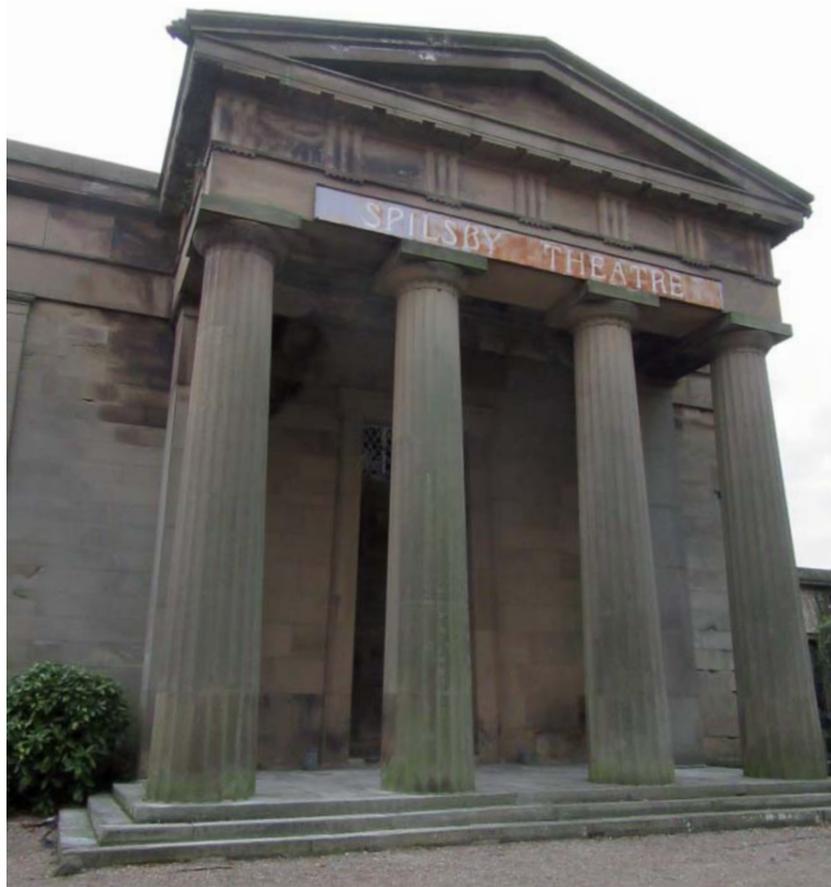
1.1

The south elevation is the main facade of the building. The imposing Doric portico and brick-built wings to either side survive largely unaltered from the 1820s. The stone walls of the portico are backed with brickwork. The stone is generally in good condition and well detailed with little deterioration other than the significant problem cracking and spalling caused by corrosion of the iron cramps used in the original construction to tie the stones together and to the backing wall. This is discussed in detail in the structural survey report.

The best cure is to remove all the rusting iron cramps, and replace them with new stainless steel. This is hardly feasible, especially with such large stones. Where stones have spalled and the rusty iron is visible, it would be possible to cut back small areas of stone, then remove the iron, and finally restore the surface with a patch of new stone. This leaves many as yet undamaged iron cramps with potential for rust and spalling in the future.

Where embedded iron is continuous, as in an iron frame, there is an effective electrical method of halting corrosion called Cathodic Protection (CP), also known as Sacrificial Anode Cathodic Protection (SACP). By inserting anodes (which may be Magnesium or coated Titanium) close to the rusting iron, a small electrical current flows through the stone, and this protects the iron from further corrosion. At Spilsby theatre, the cramps are independent and not connected together, so for CP to work, it would be necessary to electrically connect the cramps by inserting a ribbon of wire within the bed joints. CP may be cost effective if scaffold access to the whole stone façade is needed anyway.

Treating the stone with a water repellent coatings such as Silane or Siloxane, would be a cheaper way to reduce the rate of corrosion in the embedded iron. These clear coatings form a barrier against water ingress. They penetrate the stone and reduce the wettability of the masonry surface, yet the pore structure remains open and "breathable". By shedding water this treatment keeps the stone drier and hence the corrosion rate of iron is reduced, so the old cramps should last longer. (Reference 2)

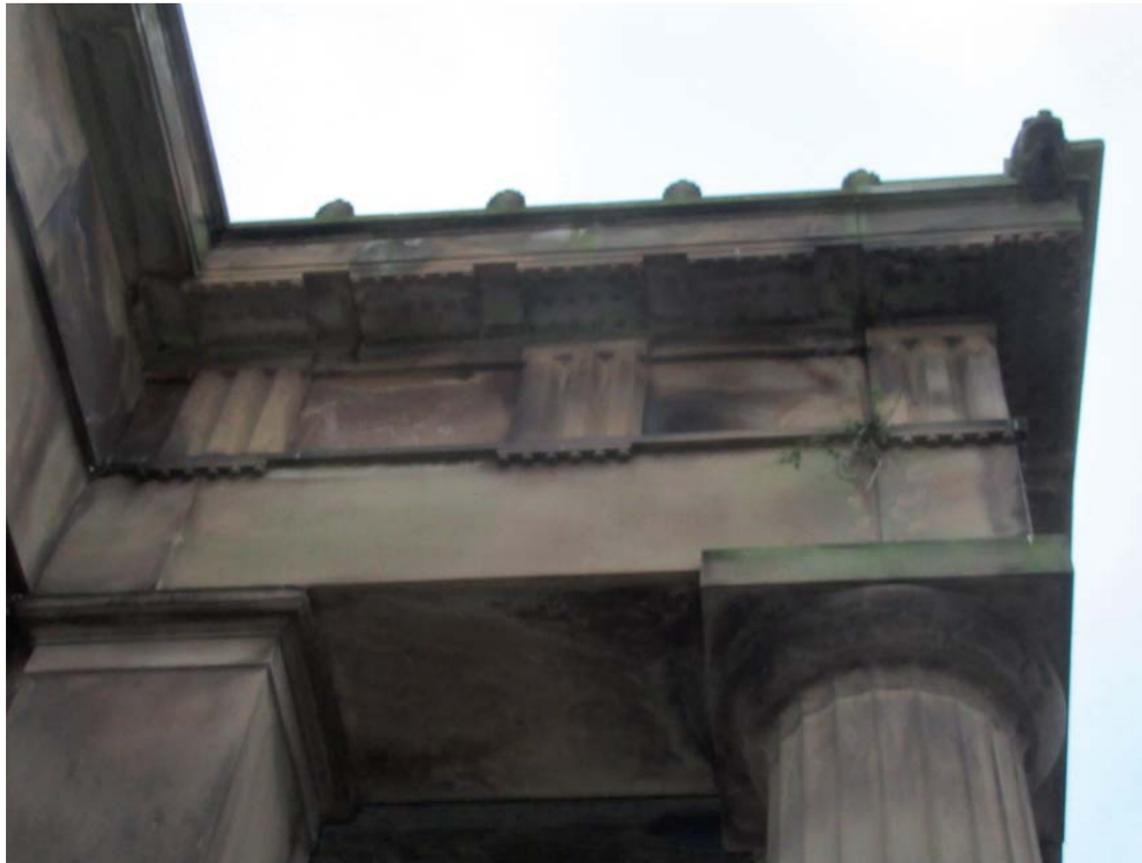
1.5

The south-western end of the portico with water staining visible. The stone is largely undamaged. Vegetation has begun to grow in joints where mortar is missing.

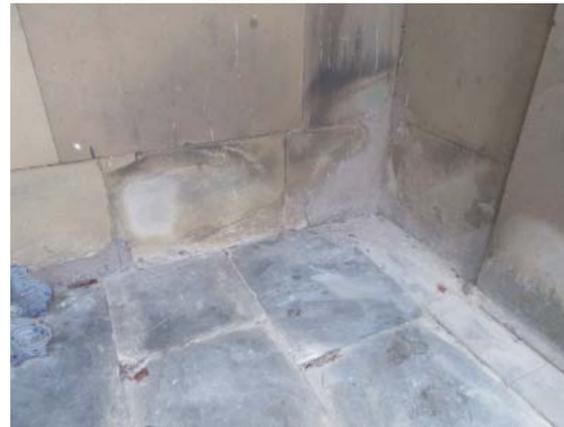
1.10

Staining and deterioration from damp, at the back of the portico where the stone is less able to dry out. Water-repellant treatment might be beneficial in these areas and should be considered at the next design stage.

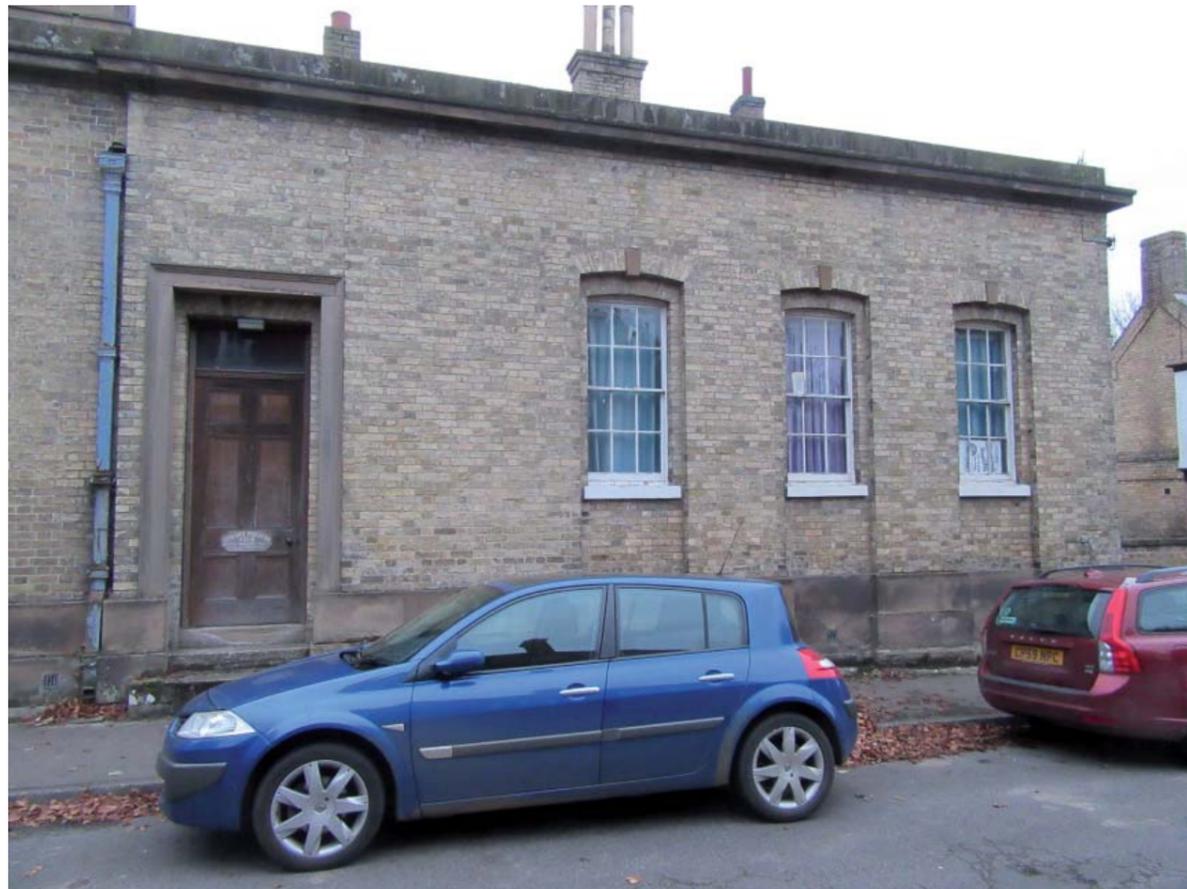
2.1

Detail of the door and plinth: staining and mild spalling from rising damp; missing pointing. Rainwater goods in need of refurbishment or replacement.

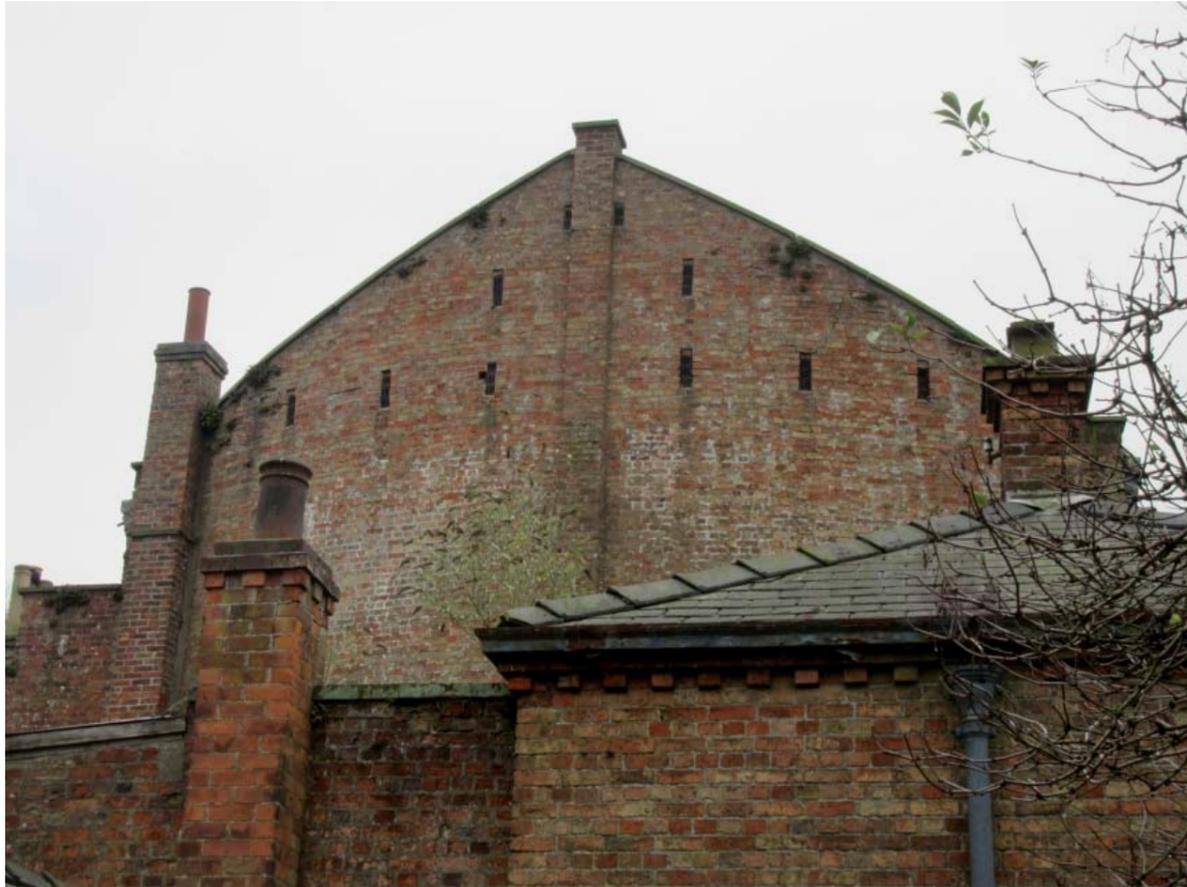
3.1

North wall of the courtroom: the brick and brickwork are in good condition with only localised repointing needed.

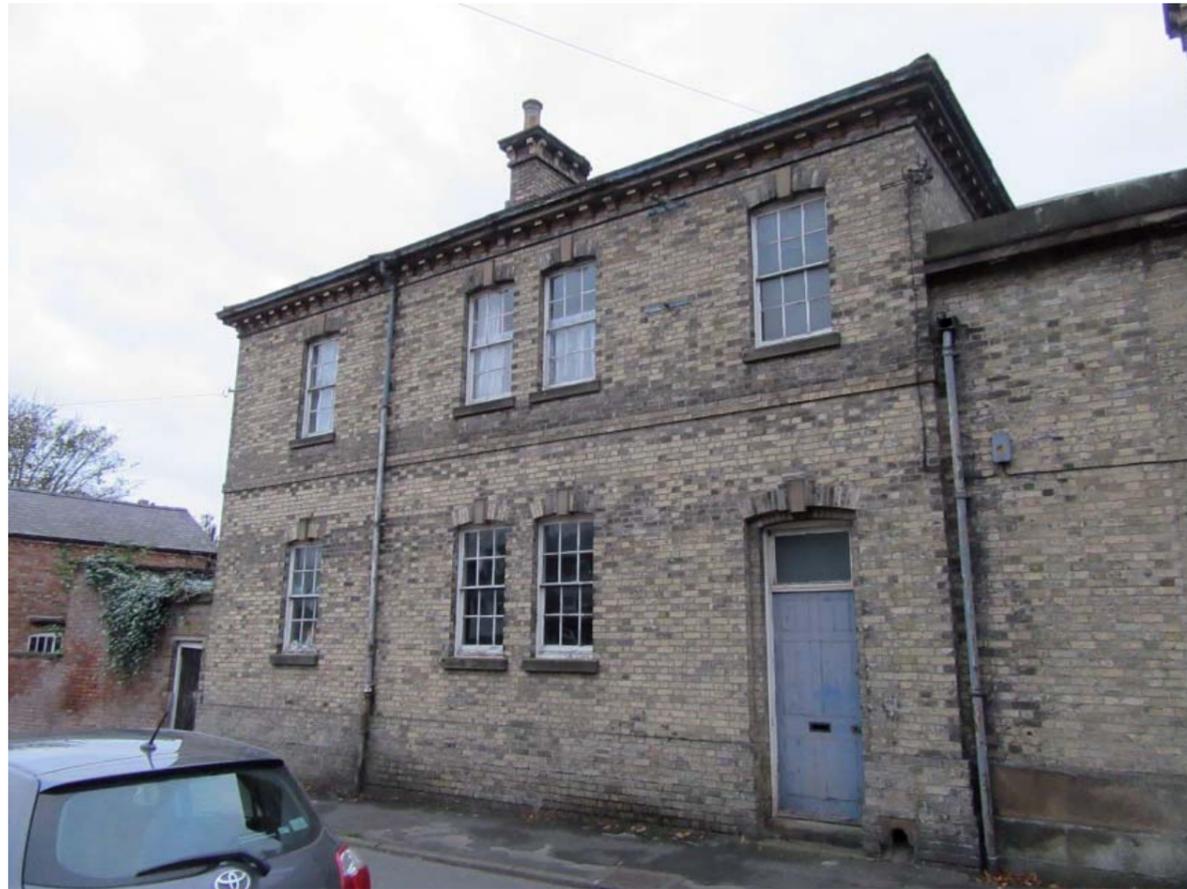
4.1

The police house dates from the 1870s. As elsewhere, it is well built with no signs of structural problems. Brickwork is in good condition with only localised repointing needed. The joint between the 1820s and 1870s brickwork can be seen at the far right of the photo. There are no stone dressings or plinths.

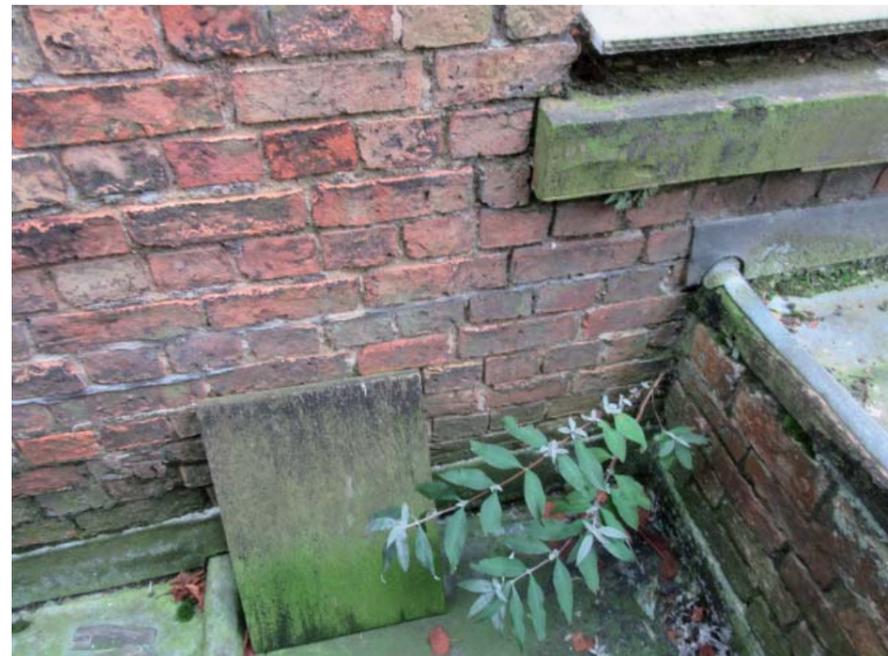
7.12

Missing lead has caused deterioration of the brickwork and vegetation growth.

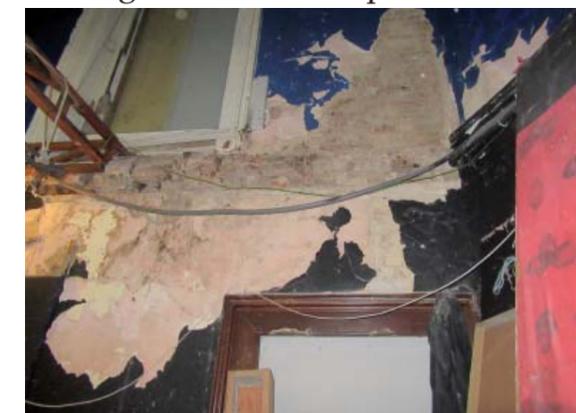
10.5

Damage to finishes at points of water ingress.

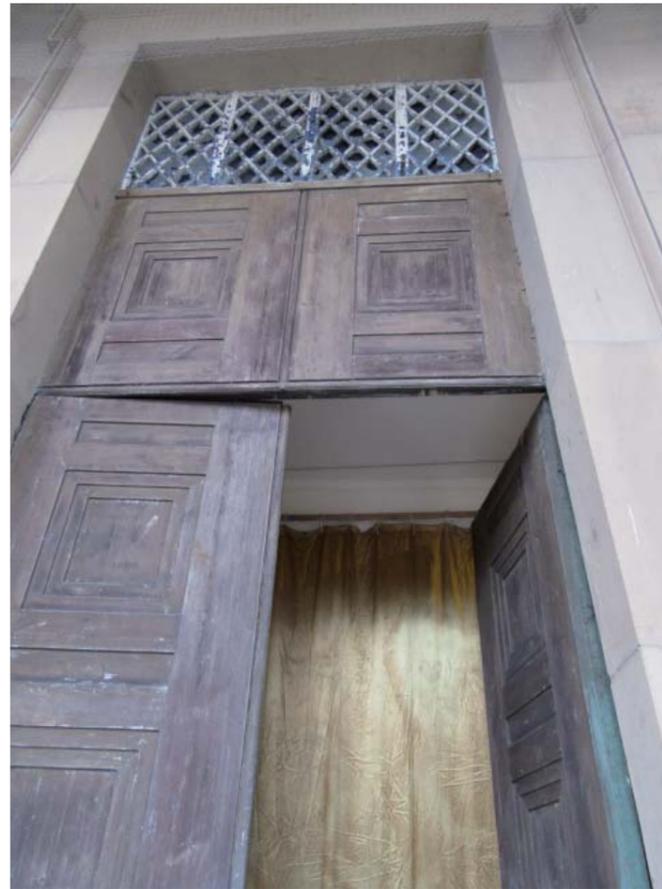
11.1
The portico door is so substantial as to be beyond deterioration and is only in need of cosmetic attention. Ironmongery is complete and operable.

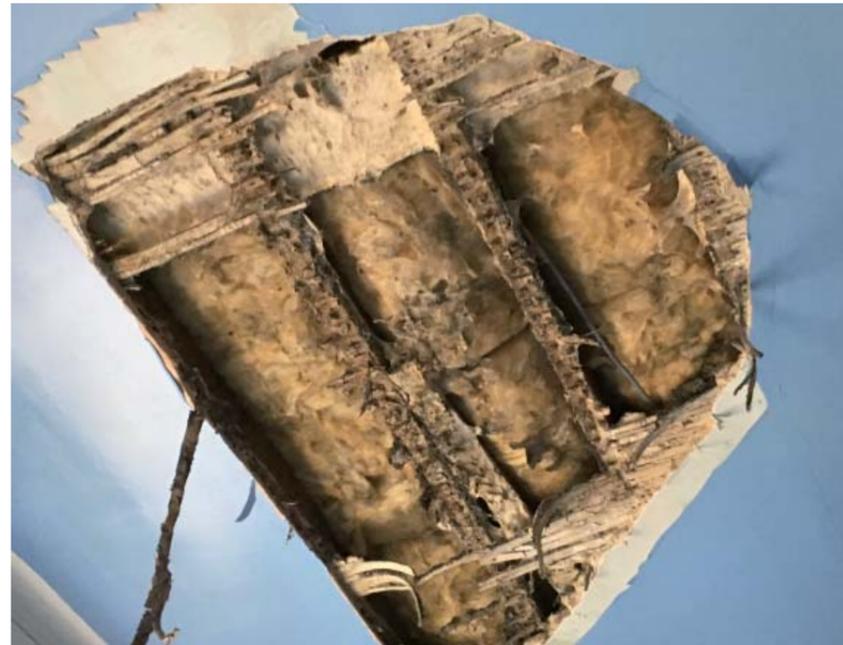
The partial collapse of two of the main trusses in the courtroom is a serious problem, preventing the use of this space by the public. However the more immediate problem, and the one with the potential to cause more widespread damage is the condition of the roofs. These are letting in water in a number places, which will cause cumulative damage to wooden structures and internal finishes. Photo 14.1 shows a recent collapsed portion of the ceiling of magistrate's room. Wet plaster gains weight considerably, and wet rot can be seen on the ceiling laths, not visible from the loft space through the mineral wool. The room is now out of use.
