Spilsby Theatre, Spilsby, Lincolnshire. Structural Overview **November 3, 2017**

1. Introduction

Condition Survey Facade

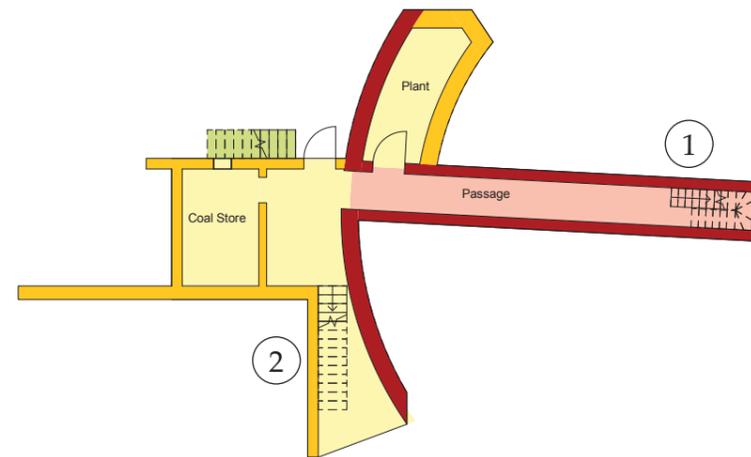
① prisoner's tunnel and stair to courtroom

② access arrangements to the tunnel are different on the 1820s plans

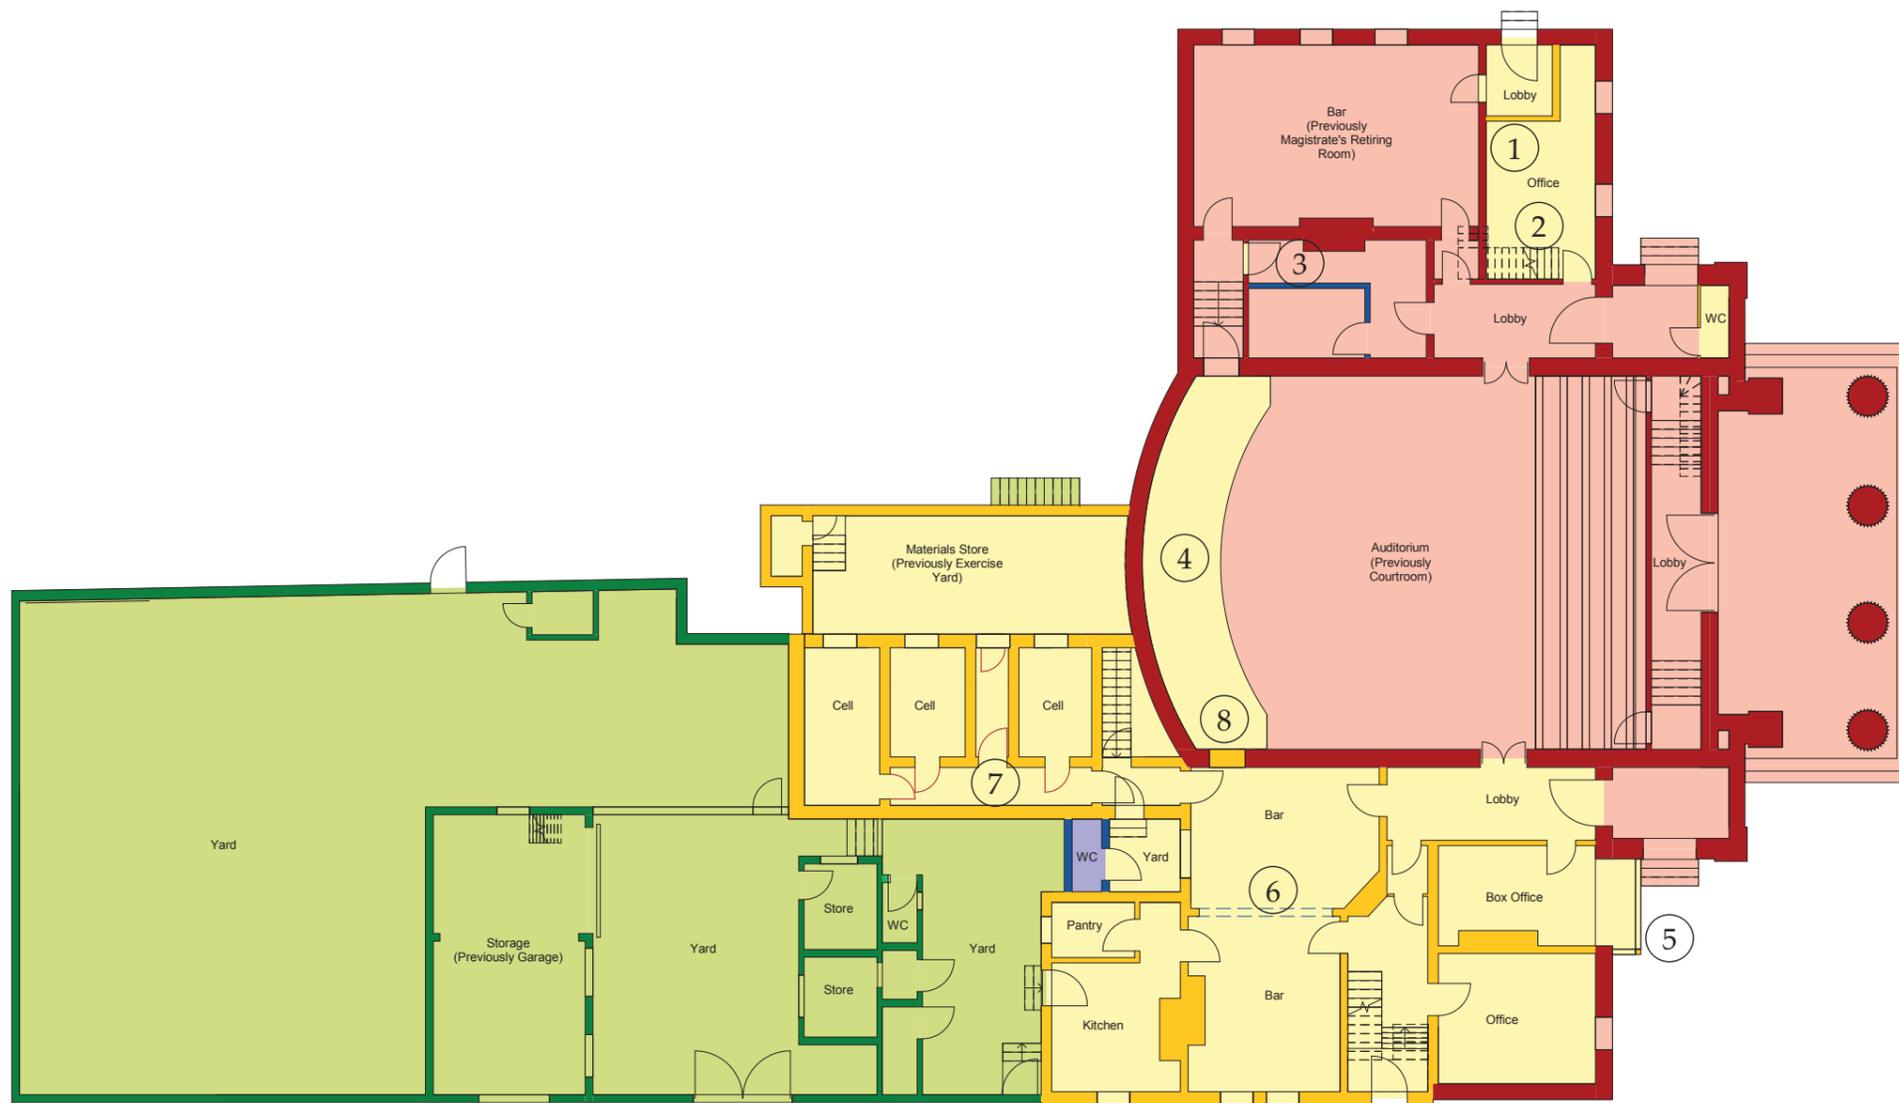
Existing Building Significance, Ground Level

- ① original fireplace has been removed
- ② although a stair is shown on the 1820s plans, this appears to date from the 1870s
- ③ doorway dates from the 1870s
- ④ judge's dais is 1870s timber construction
- ⑤ bay window dates from 1870s conversion to police station
- ⑥ opening between previously separate rooms dates from 1980s
- ⑦ the iron cell doors were retained from the original prison and reused for the police cells in the 1870s
- ⑧ bricked up in the 1870s

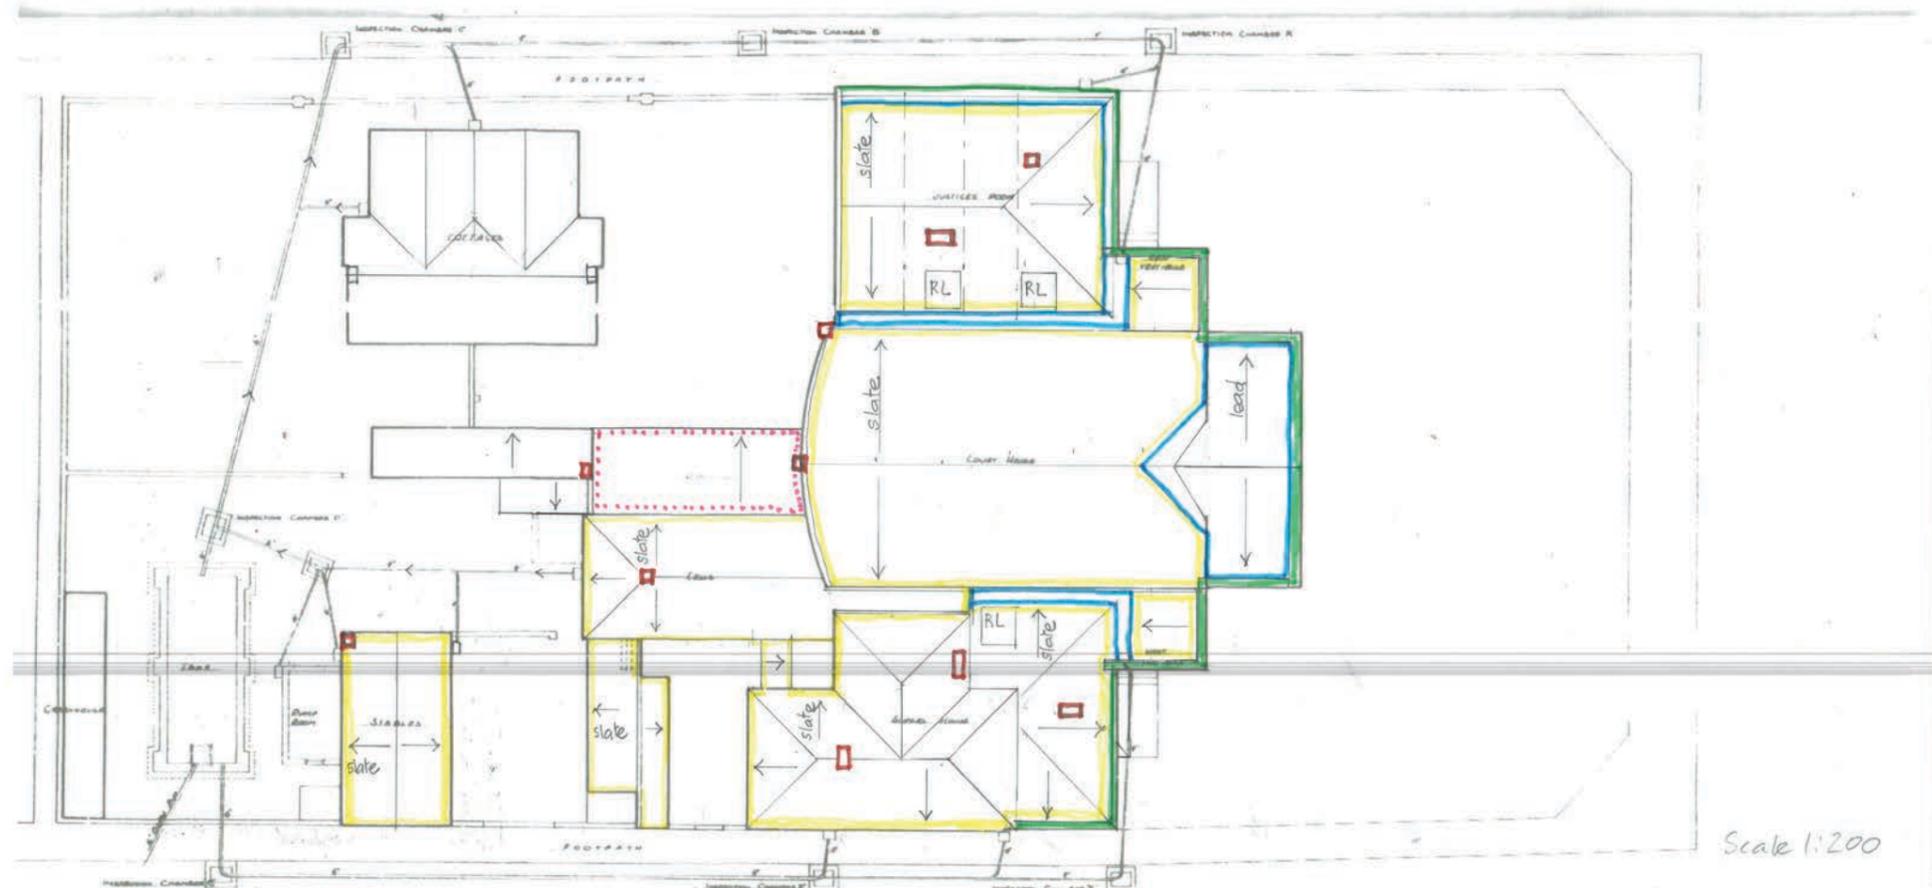
ROOF STRUCTURE Structural Survey Nov 3 2017

Common Rafter
have dropped ~150
and spread outwards
which has caused
crack in brickwork.

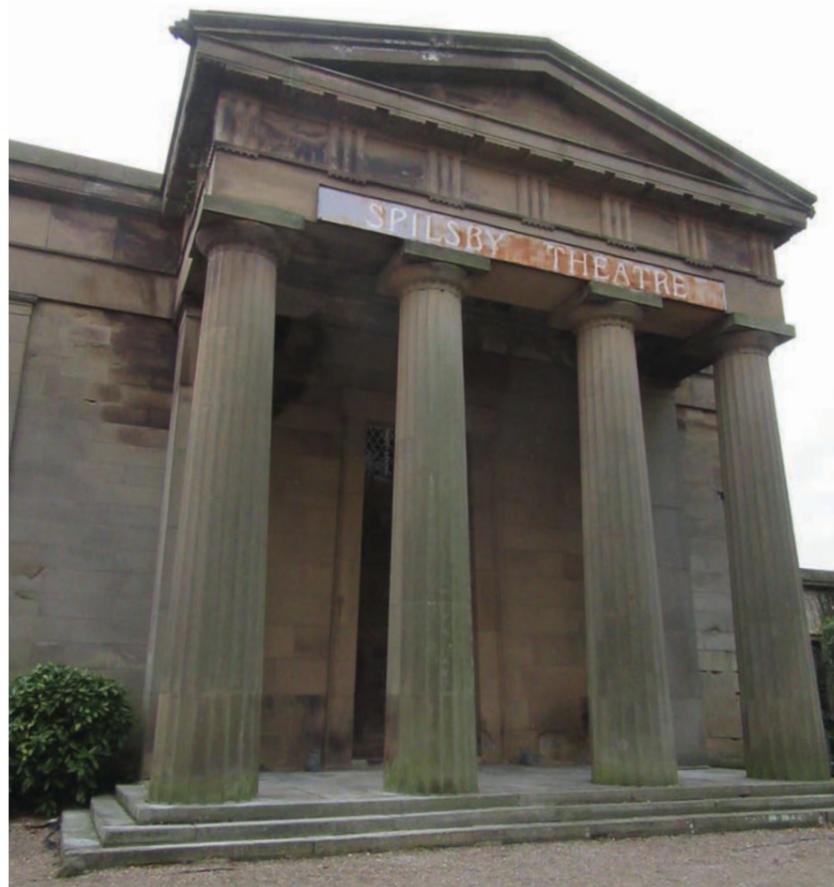
1.1

Panel of stone wall showing the typical extent of the spalling and cracking.

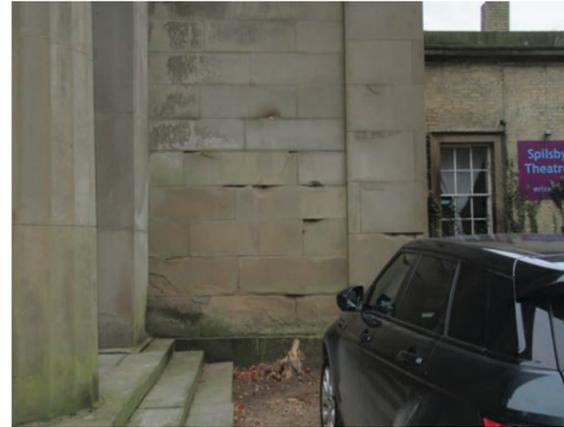
1.2

Typical damage to stone from the corrosion of the iron cramps.

The best cure is to remove all the rusting iron cramps, and replace them with new stainless steel. This is hardly feasible, especially with such large stones. Where stones have spalled and the rusty iron is visible, it would be possible to cut back small areas of stone, then remove the iron, and finally restore the surface with a patch of new stone. This leaves many as yet undamaged iron cramps with potential for rust and spalling in the future.

Treating the stone with a water repellent coatings such as Silane or Siloxane, would be a cheaper way to reduce the rate of corrosion in the embedded iron. These clear coatings form a barrier against water ingress. They penetrate the stone and reduce the wettability of the masonry surface, yet the pore structure remains open and "breathable". By shedding water this treatment keeps the stone drier and hence the corrosion rate of iron is reduced, so the old cramps should last longer. (Reference 2)

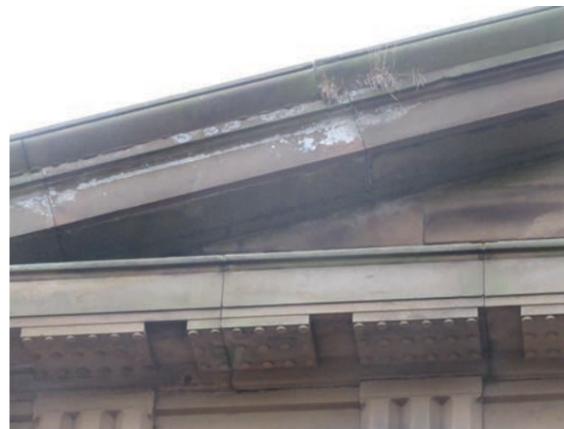
1.9

Cornice: vegetation has taken root where mortar is missing.

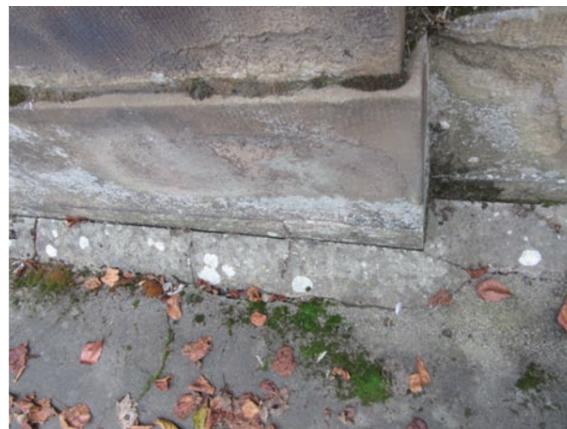
2.2

Detail of the door and plinth: staining and mild spalling from rising damp; missing pointing. Rainwater goods in need of refurbishment or replacement.

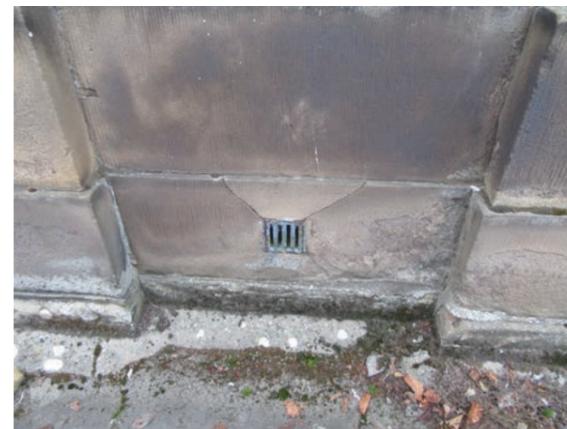
2.3

Detail at the base of the plinth: the condition of the stone under the cement fillet should be investigated. A more appropriate detail might be considered or the fillets renewed.

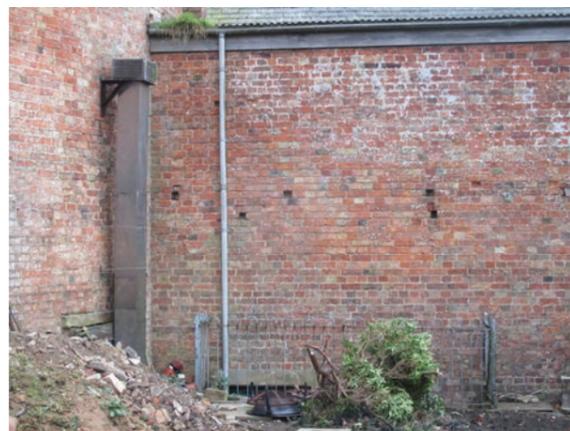
3.2

Detail of the north wall of the courtroom. Pointing is deteriorated or missing from the copings and vegetation has started to take root in open joints.

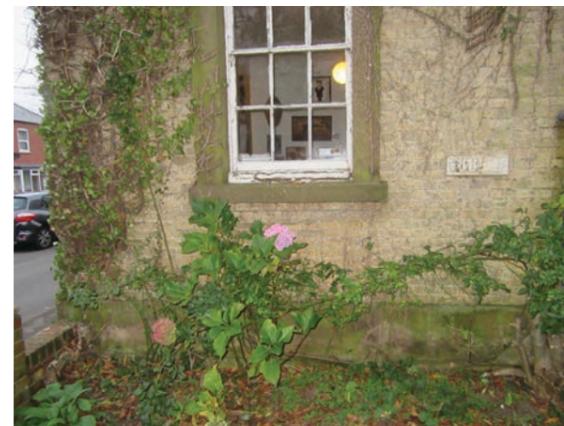
4.3
Gutters and downpipes are likely to have been in service for 140 years, without much attention, and may yet only need refurbishment rather than full replacement.

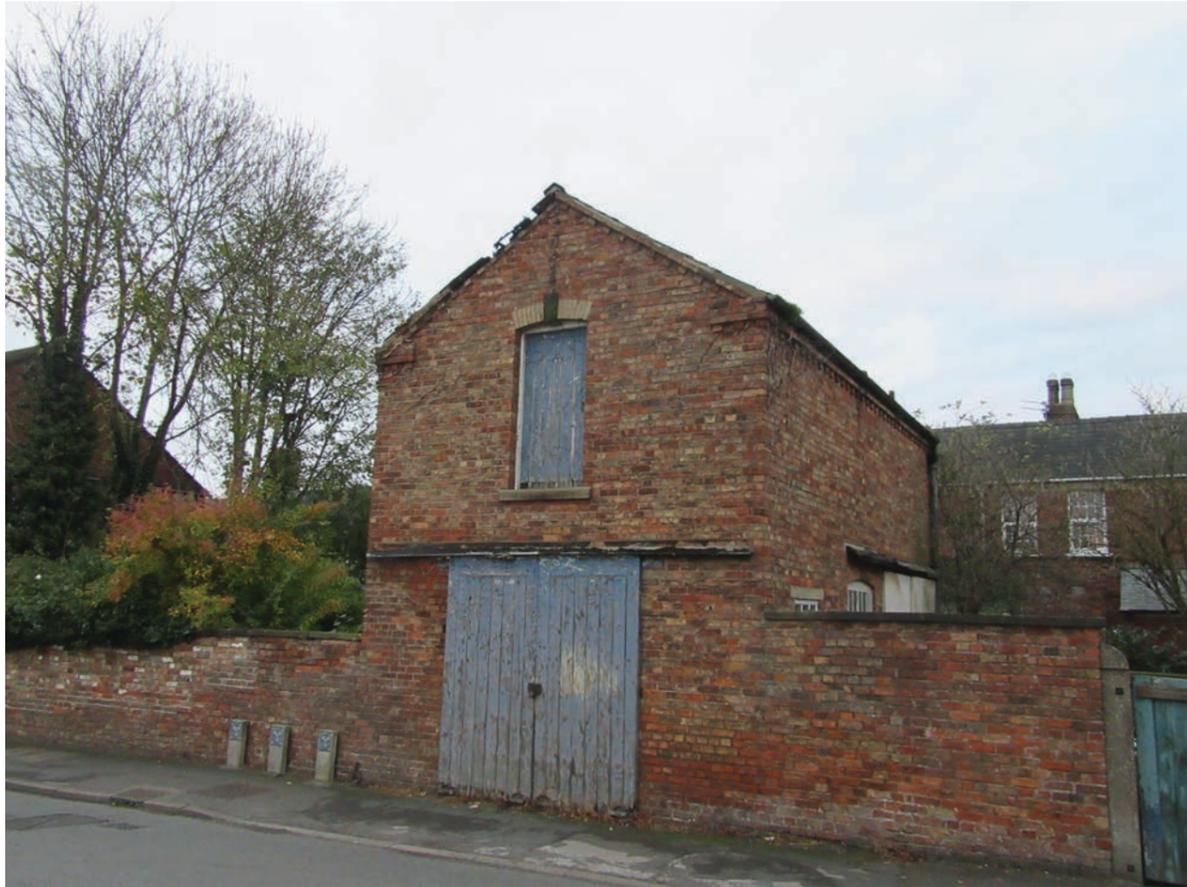
5.1

Former police garage. The yard buildings are less substantially built than the main buildings, and have suffered to a much greater extent from unchecked vegetation, now removed by the current occupants. Nevertheless, the brickwork and pointing are in fair condition. Exposed wooden components such as doors and windows have significant rot and are likely to need replacement.

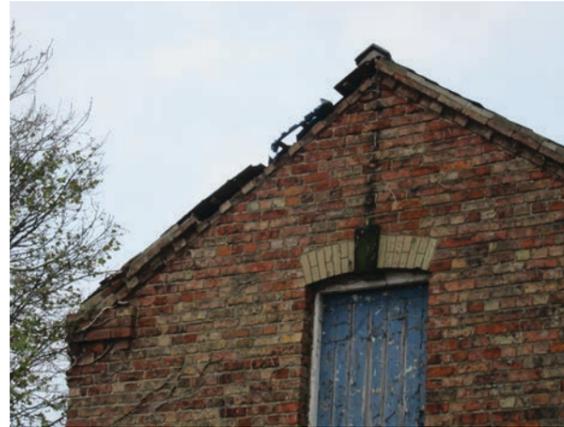
5.2

Gable: slating and undercloak missing.

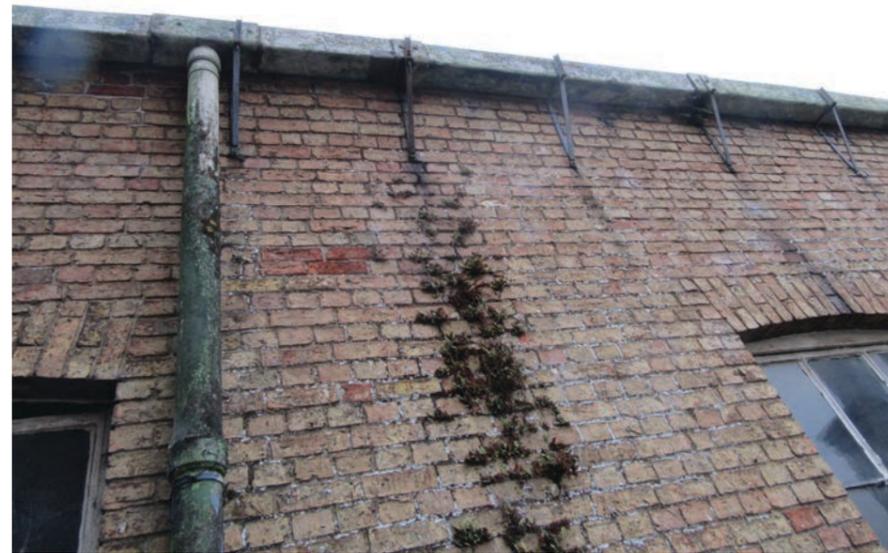
7.2

Plant growth at a gutter leak.

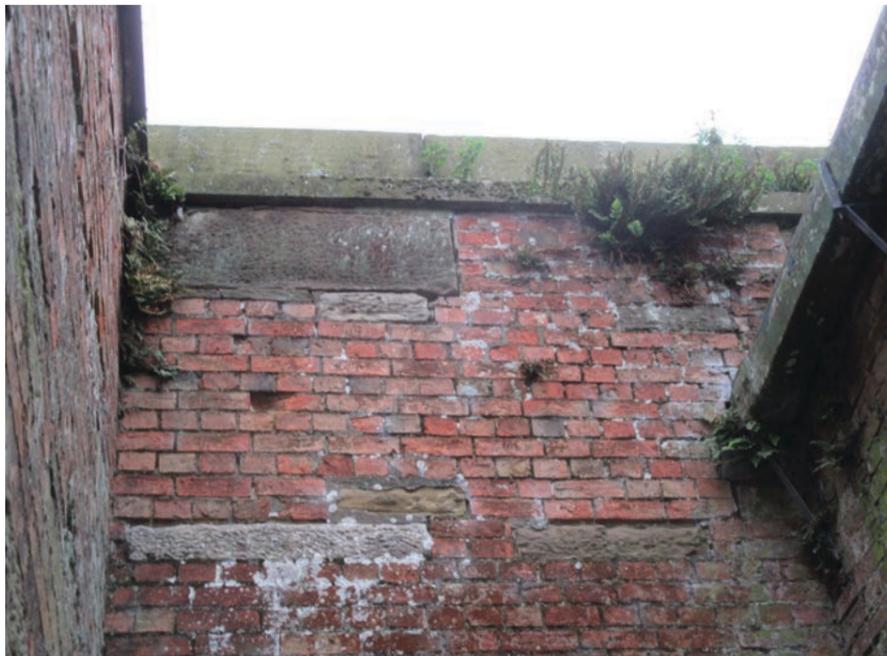
7.3

Reverse of portico wall: vegetation needs to be removed and pointing to the copings and brickwork repaired. The intermittent stones that create a bond between the stone facings and brickwork backing wall can be seen.

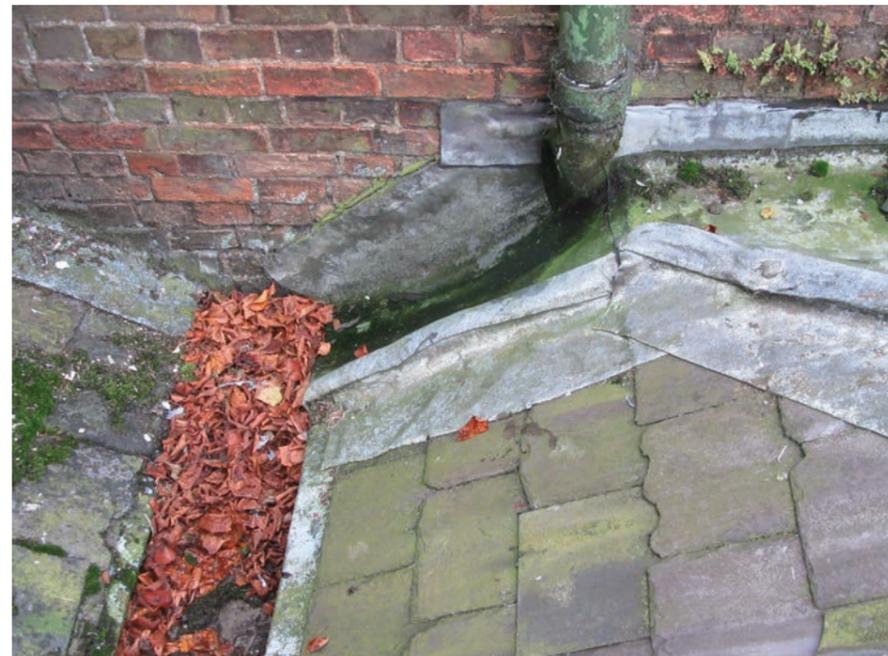
7.4

The slating and leadwork were originally carried out to a high standard. The absence of sarking felt and presence of torching, to be seen from inside the roofspaces, suggest that the roofing might not have been overhauled since it was first installed, possibly as long ago as the 1870s. The roofing now needs complete replacement. The photograph shows a gutter outlet that passes under the wall and runs internally to a downpipe in the porch at the side of the portico (there is the same arrangement on the west side of the building). It is prone to blocking and opening out the hole in the wall to improve access for clearing it is likely to help.

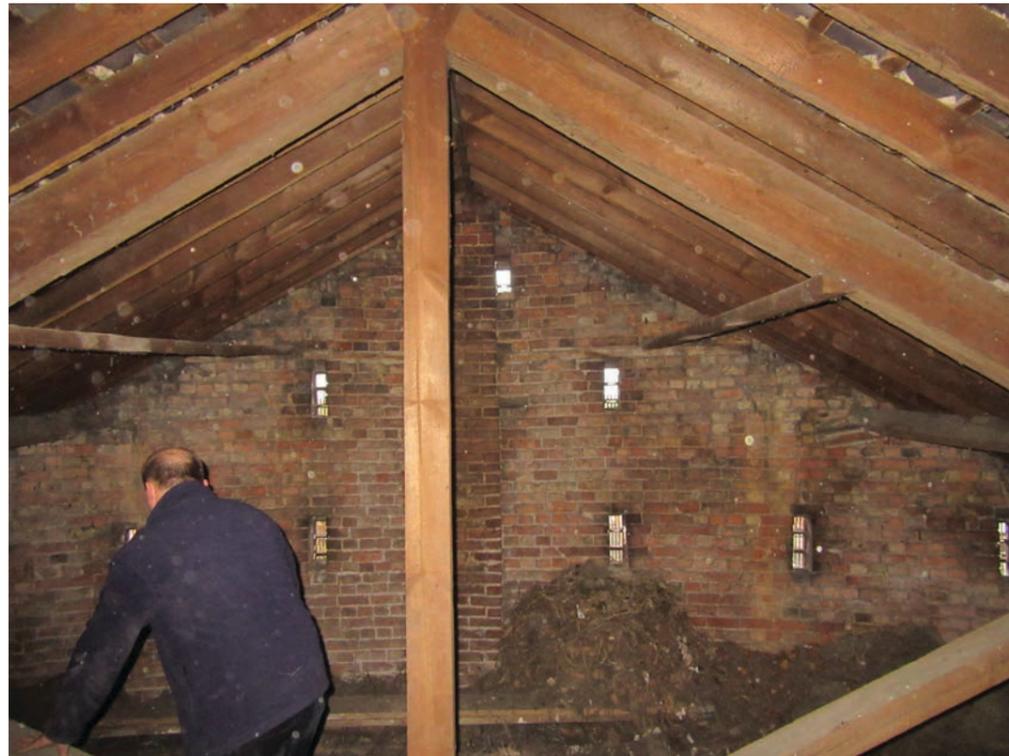
8.1

Northern end of the courtroom loft with the last main truss visible. The pile of material at the gable wall is the work of birds getting in through missing grilles in the ventilation slots.

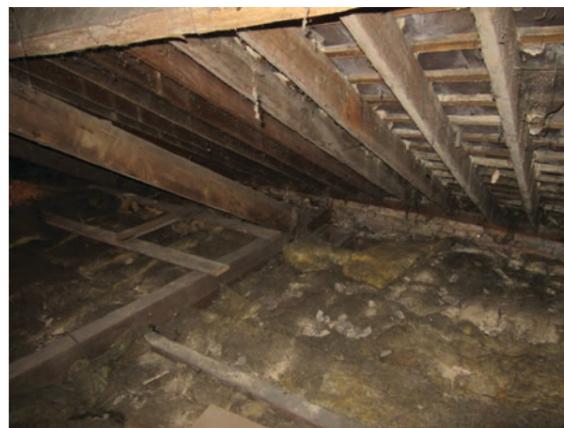
8.4

The roof timbers are generally in good condition. The torching to underside of the slates can be seen.

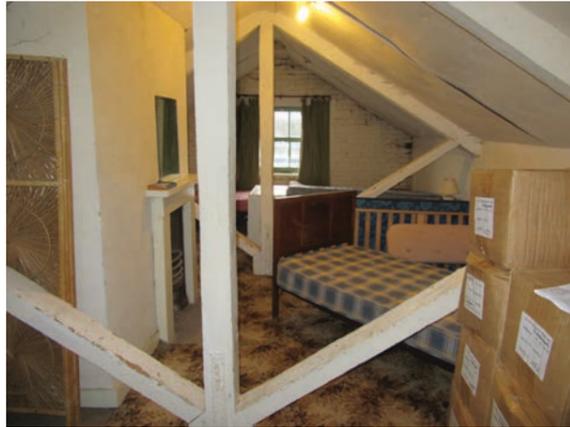
9.1 Occupied loft space above the magistrate's retiring room. The proposals include an adaption to the roof trusses to make a more useable passageway on the left-hand-side.

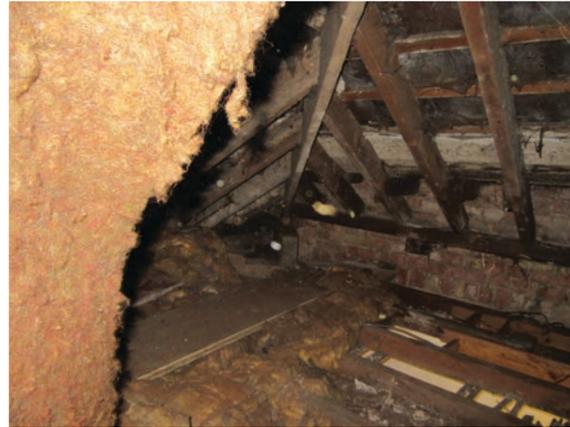
9.2 Typical roospace adjacent to occupied loft. In general, in all roofspaces, rafters and ceiling joists are in fair condition, with some rot in vulnerable locations.

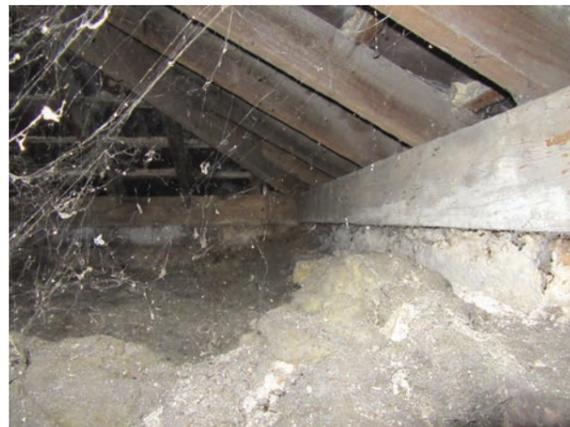
9.5 Typical wall plate, in fair condition.

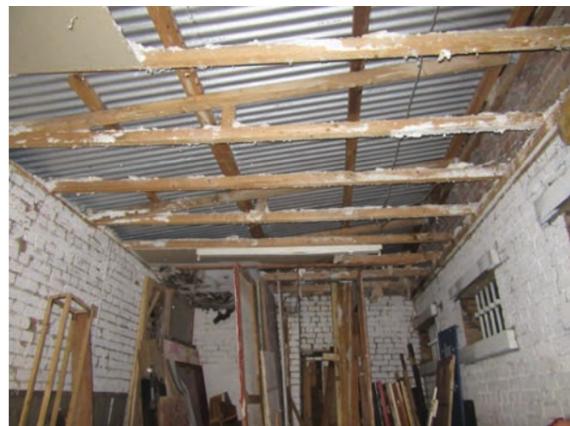
9.9 Temporary roof above the former exercise yard. The high level windows to the right are at the backs of the cells.

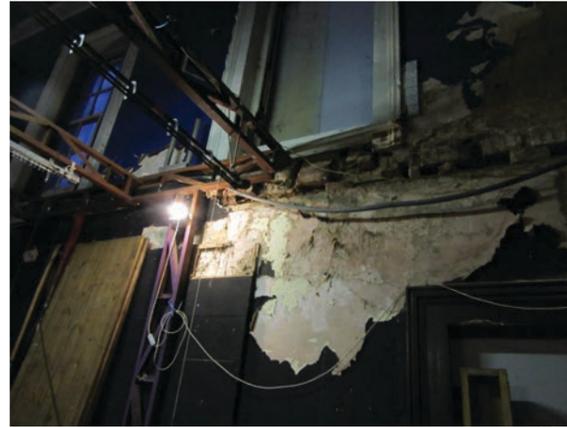
10.2

Damage to internal finishes from water ingress at the lead valley gutter under the windows. A wooden ring beam built into the brickwork at cill level, common practice at the time of construction, has become exposed and its condition will need further investigation at the next project stage.

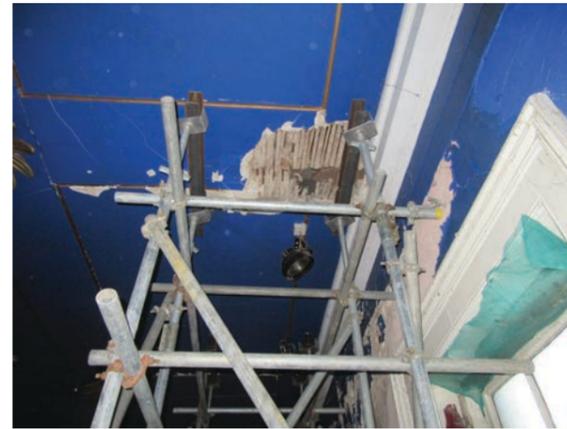
10.3

Damage to finishes at caused by the movement of one of the two damaged main trusses. The scaffold is the temporary support to the trusses.

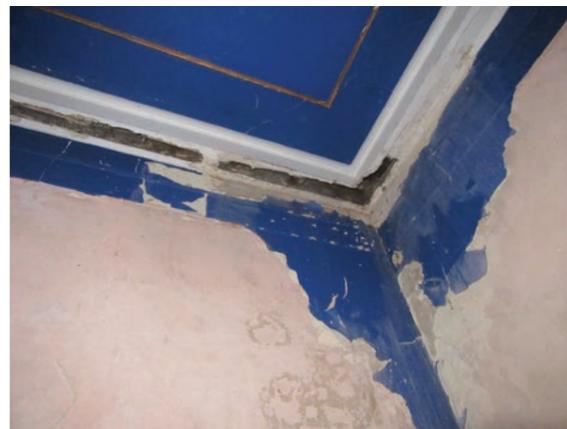
10.4

Damage to finishes at points of water ingress.

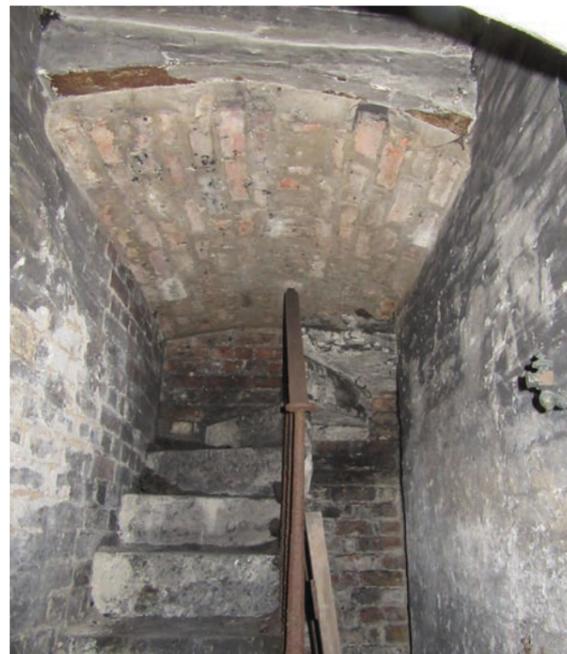
11.5
The prisoner's entrance into the middle of the courtroom from the tunnel is bricked up, possibly done in the 1870s (the stair and entrance do not appear on the 1976 plan based on the 1896 survey).

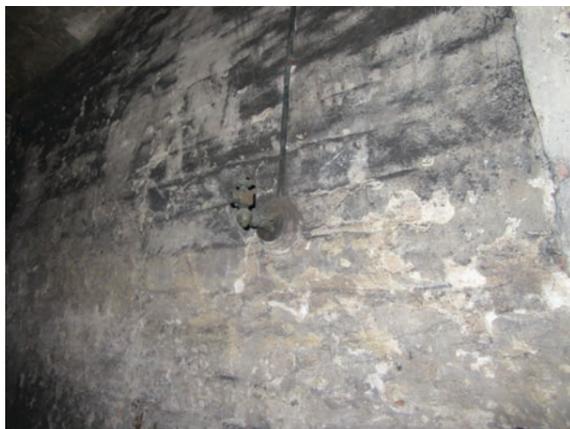
11.3
An old gas lamp fitting in the tunnel.

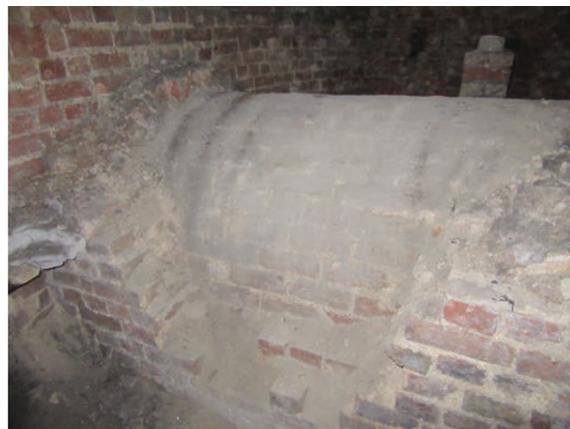
11.4
Tunnel viewed from above, from the courtroom sub-floor.

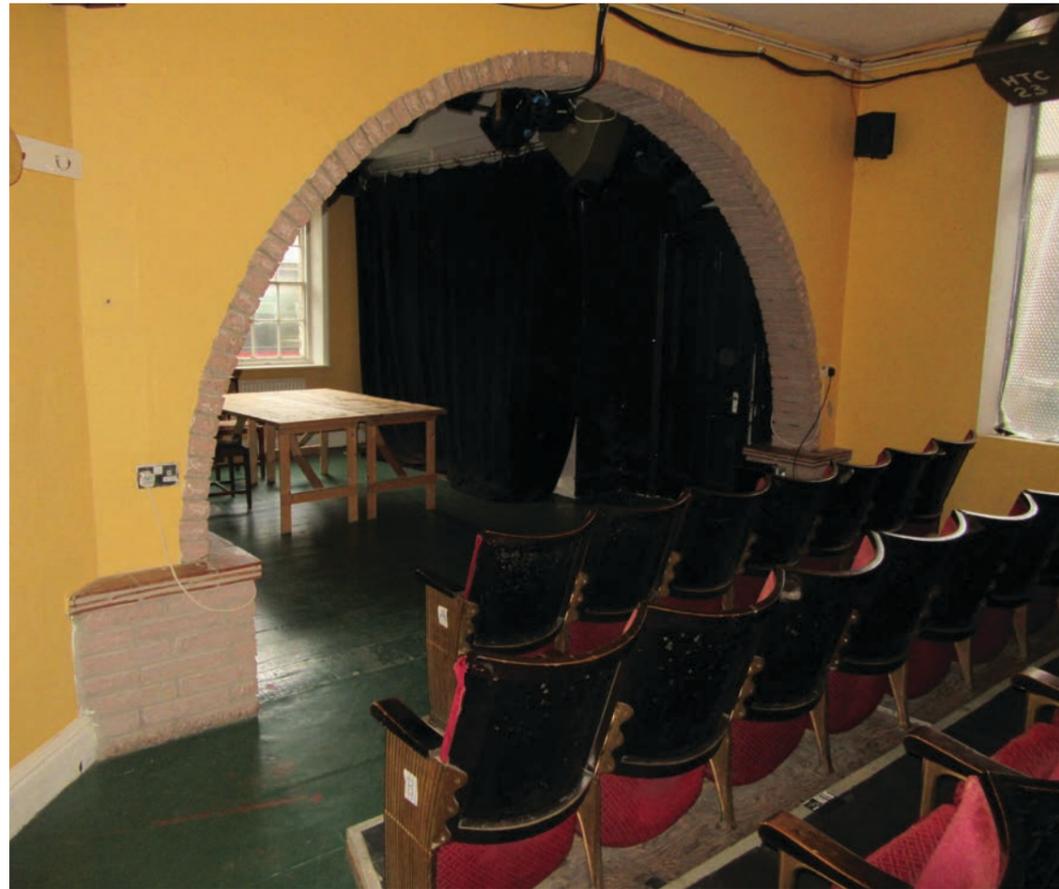
13.1

The main spaces of the police house are typical of all the rooms: finishes largely survive, in fair condition. The arch in the photo was made in the 1980s, connecting two previously separate rooms to form a tapas restaurant. The corner fireplace, to the left of the photo, is lost.

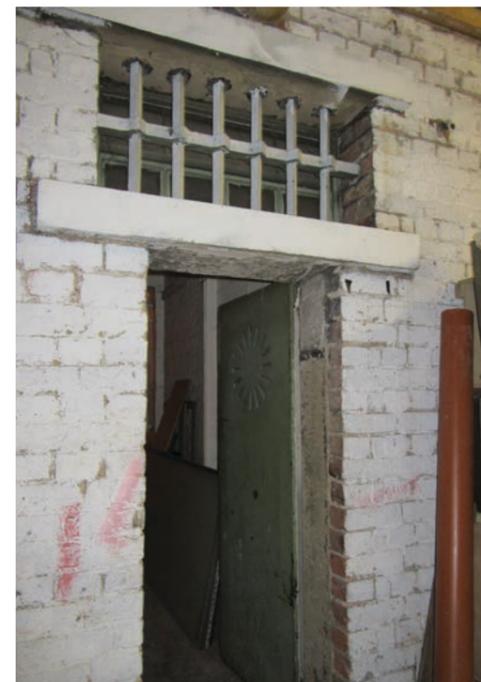
13.5

One of the cell entrances: The cast iron door, with its unusual radial grille/window that can be opened and closed and cast iron "panelling" below, has the mark of an architect about it: it is an 1820s cell door from the prison, reused in the 1870s. A number of these doors crop up in the nearby houses that were built on the site of the prison.
