Spilsby Sessions House Viability Study

Architectural Report
Updated June 2022

Introduction

ROOF STRUCTURE Structural Survey Nov 3 2017

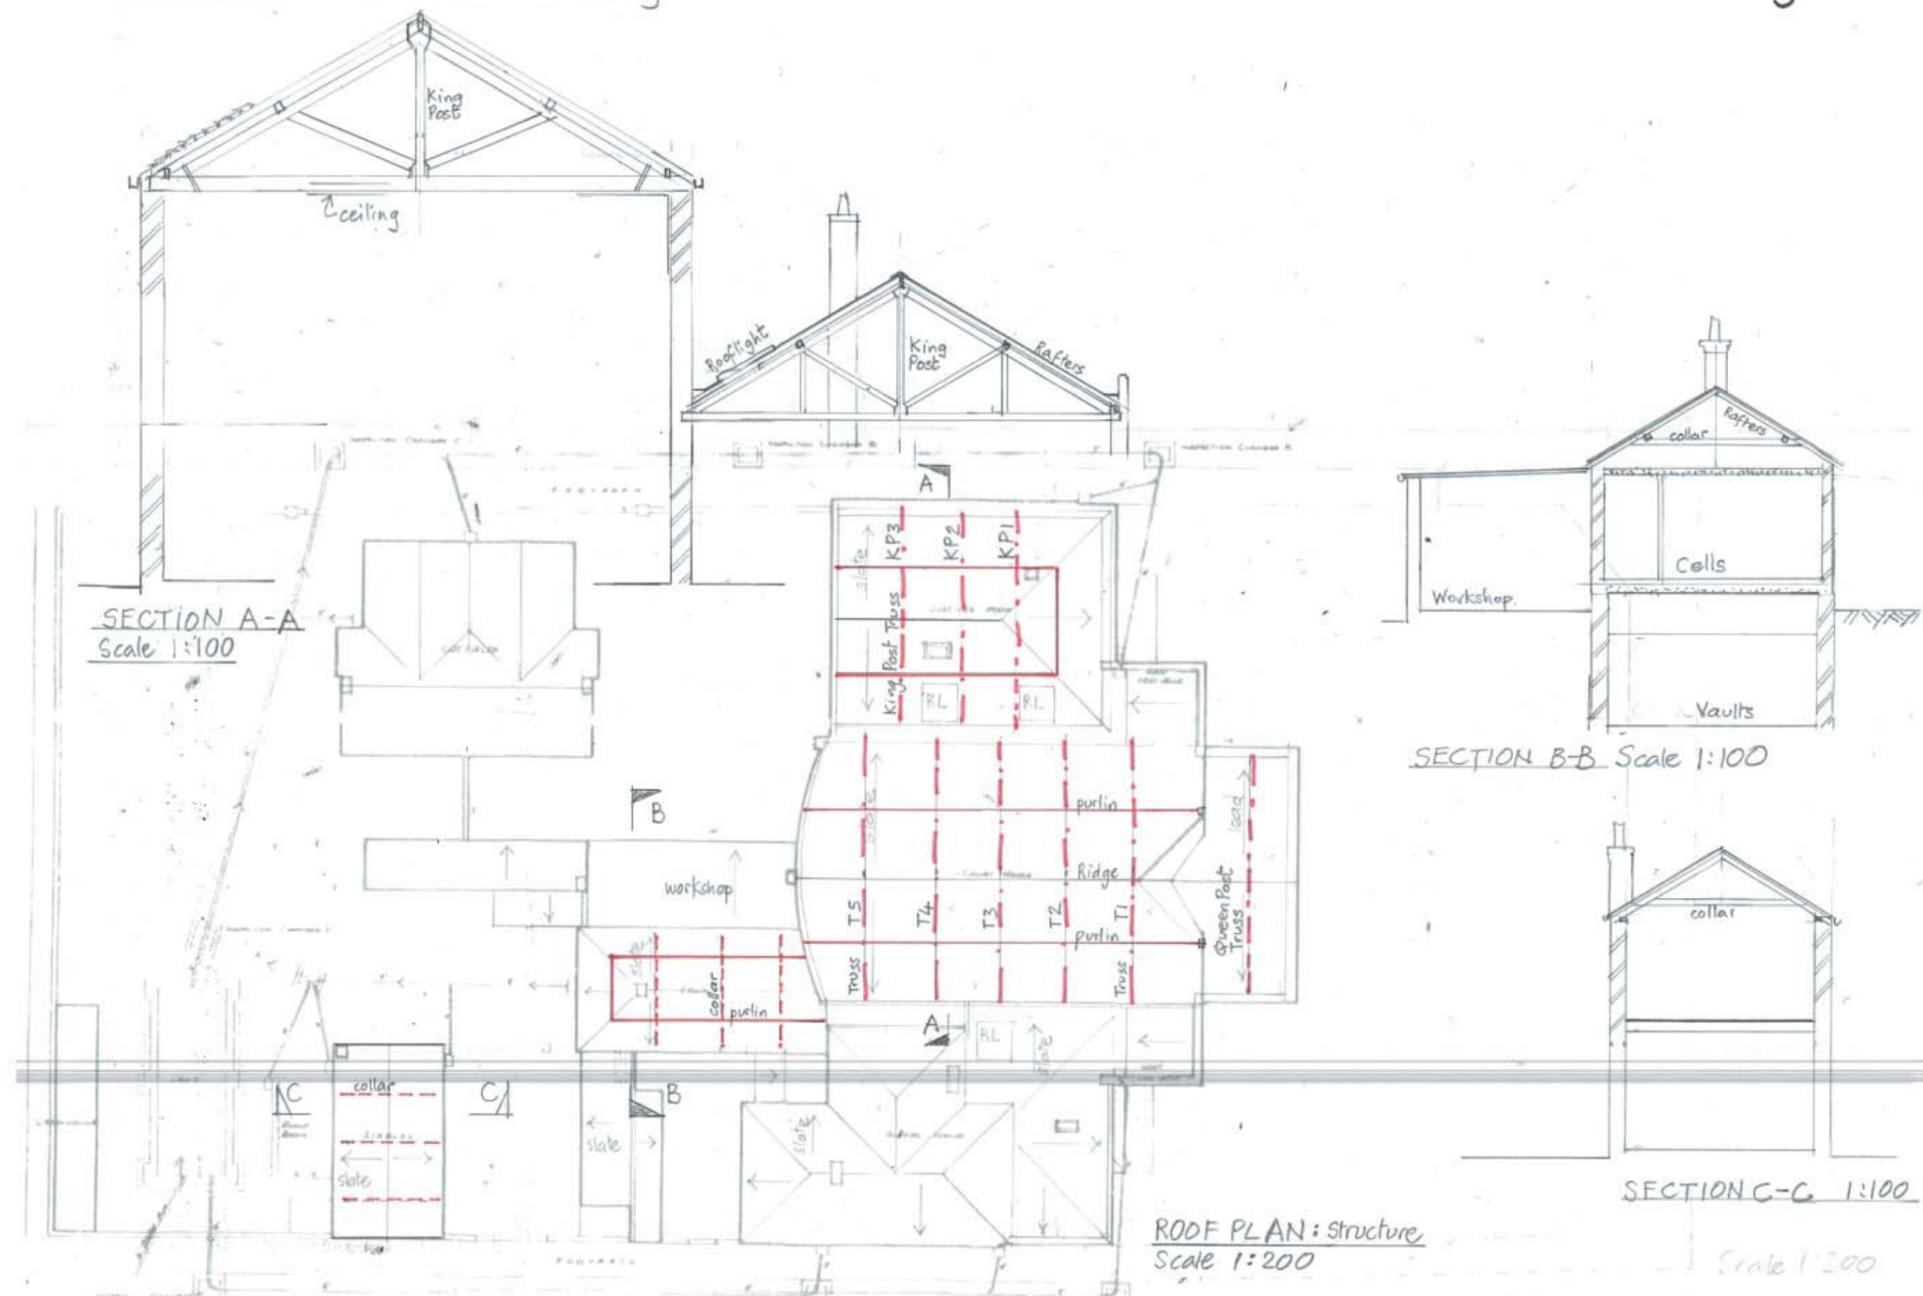
KING POST TRUSS TI OVER COURTROOM, Structural survey Nov 3, 2017
Scale 1:20

Two of the main trusses (T1 and T2, near the Portico) have suffered decay at the East end, and the bottom booms have fractured next the supporting wall. This has happened because the bearing position of the principal rafter is not over the wall - rather it falls short, and puts bending stress into the bottom boom of the truss. These trusses now sag, and this has pushed the top part of the East wall out of plumb, (see photos 1, 2 and 3, and drawing 4). The sagging has fractured the ceiling. These 2 trusses, now propped on temporary scaffolding, need to be repaired probably using new timber and steel plates spliced onto the existing timber. The trusses will need to be jacked up, in order to restore their position above the lathe and plaster ceiling. This work will mean taking off the slates, but since some of the slates are showing signs of delamination and there is no sarking felt, it will be desirable to renew the slates and leadwork. Because all the trusses are weak at their ends, it will be necessary to strengthen both ends of all 5 trusses by adding steel shoes hidden in the roof space (see drawing 4). It will also be necessary to look at the bearing ends of all other trusses, some of which were hidden from view.

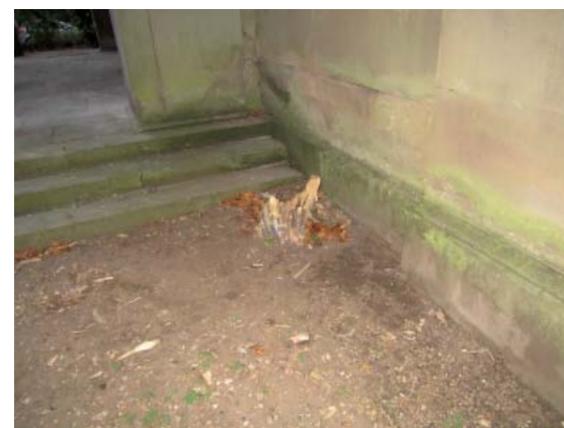
1.13

Water damage at low level. This location is not hidden from the sun but drying out was hampered by extensive vegetation.

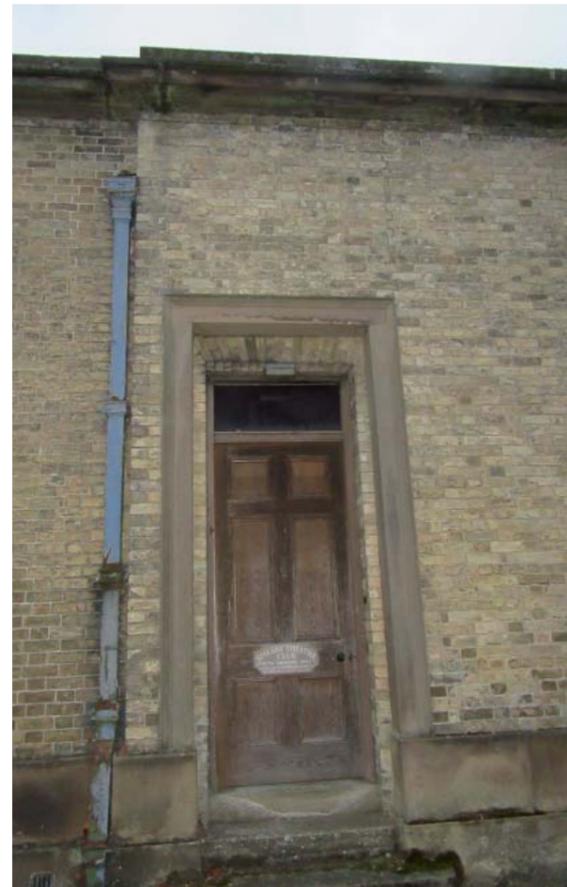
2.1

Detail of the door and plinth: staining and mild spalling from rising damp; missing pointing. Rainwater goods in need of refurbishment or replacement.

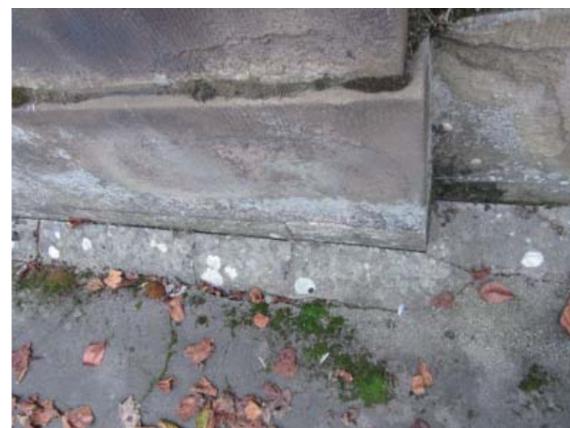
2.2

Detail at the base of the plinth: the condition of the stone under the cement fillet should be investigated. A more appropriate detail might be considered or the fillets renewed.

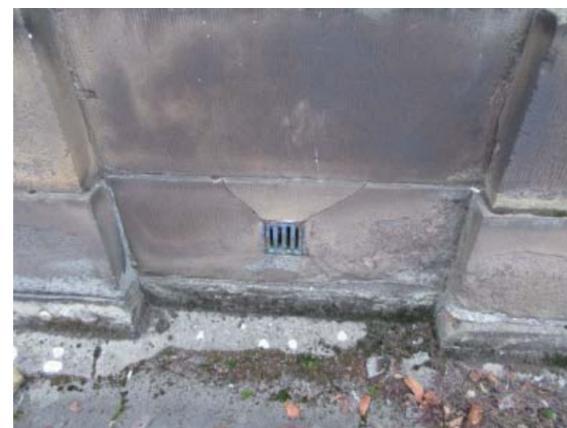
2.3

The iron floor ventilators have cracked the stone in every bay.

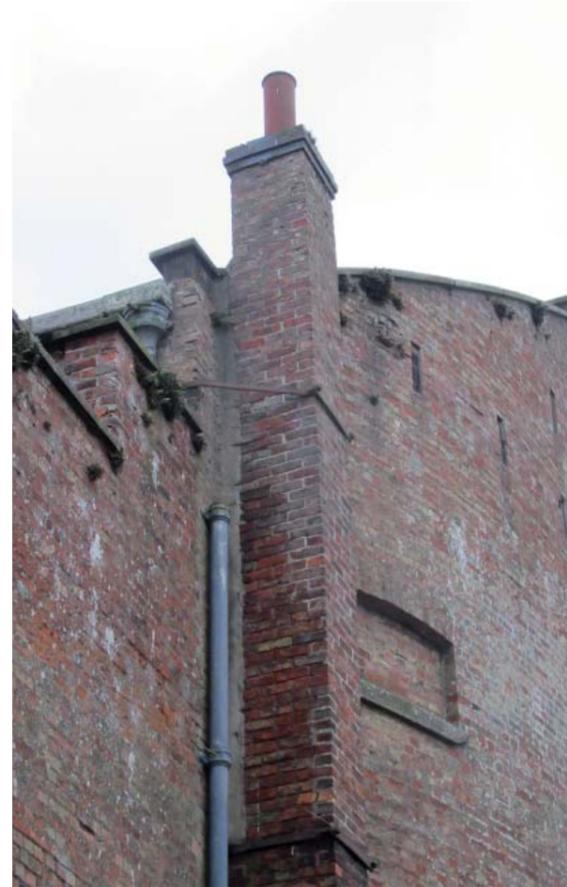
3.1

North wall of the courtroom: the brick and brickwork are in good condition with only localised repointing needed.

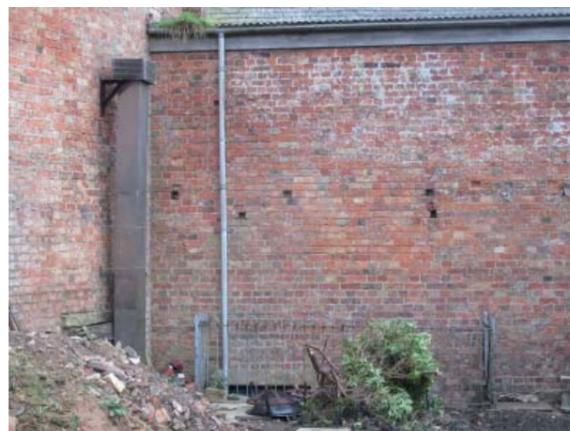
3.2

Detail of the north wall of the courtroom. Pointing is deteriorated or missing from the copings and vegetation has started to take root in open joints.

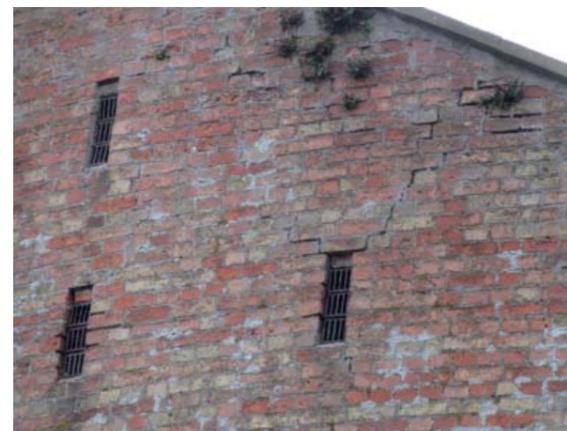
3.3

North wall of the courtroom (to left of photo) and east wall of the exercise yard (to right of photo). These walls abut the neighbour's garden at no. 5 Spence Street. The roof of the exercise yard is temporary and if replaced as part of the project, should be reversed to fall in the opposite direction and provide a gutter readily accessed from the client's side.

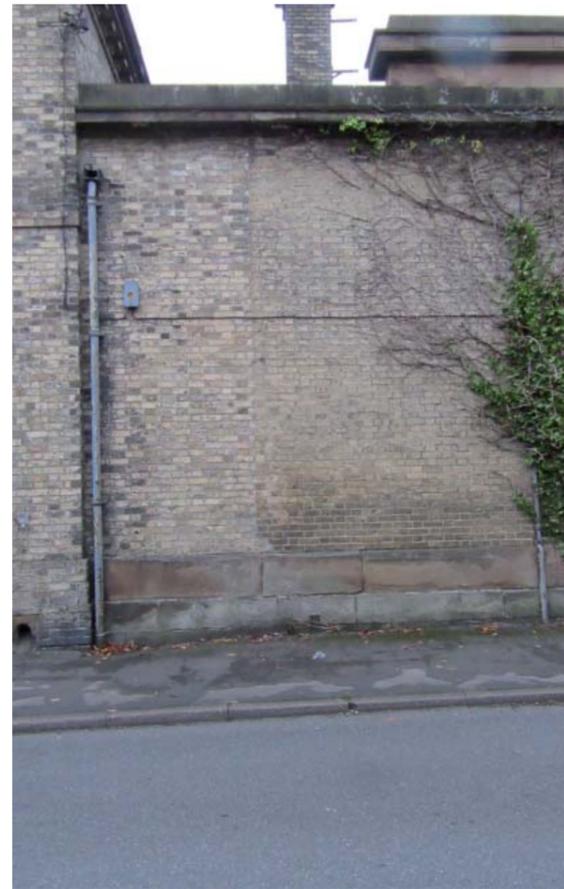
4.1

The police house dates from the 1870s. As elsewhere, it is well built with no signs of structural problems. Brickwork is in good condition with only localised repointing needed. The joint between the 1820s and 1870s brickwork can be seen at the far right of the photo. There are no stone dressings or plinths.

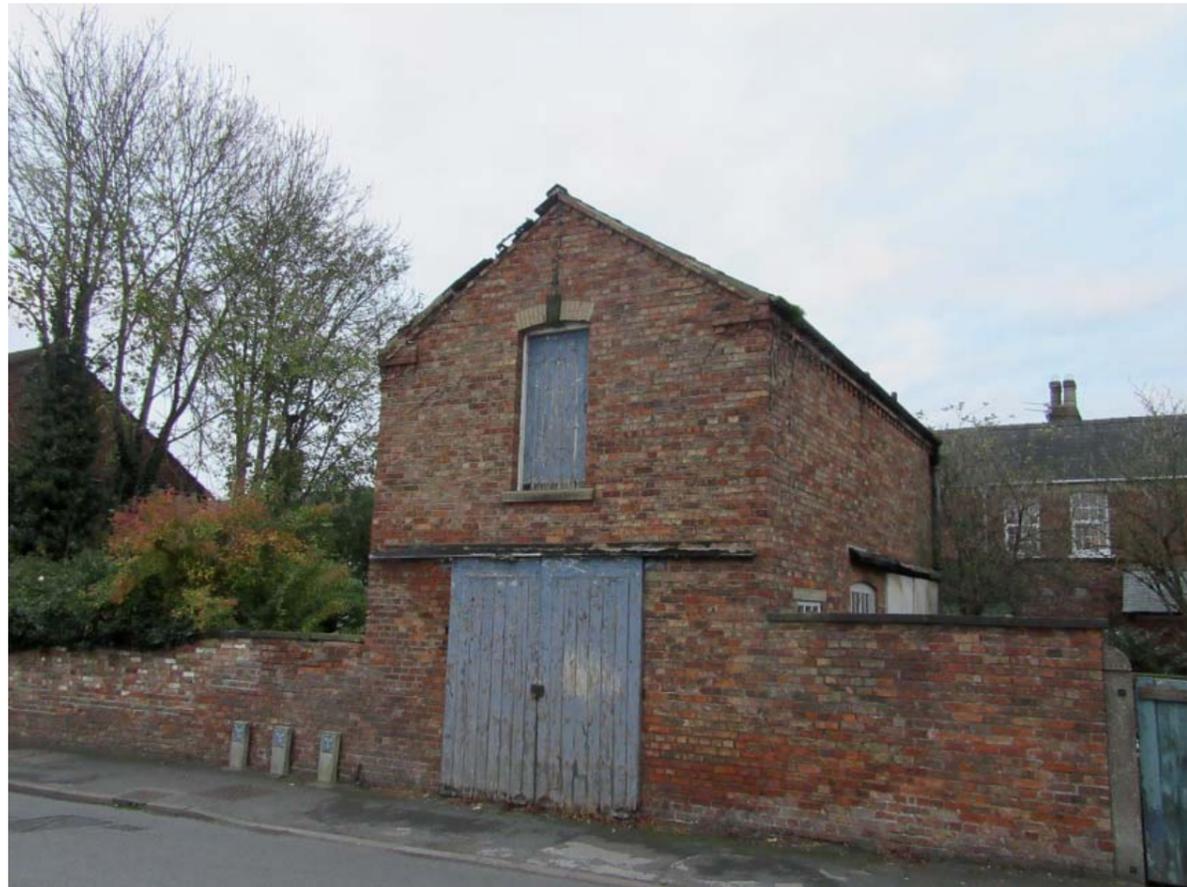
5.1

Former police garage. The yard buildings are less substantially built than the main buildings, and have suffered to a much greater extent from unchecked vegetation, now removed by the current occupants. Nevertheless, the brickwork and pointing are in fair condition. Exposed wooden components such as doors and windows have significant rot and are likely to need replacement.

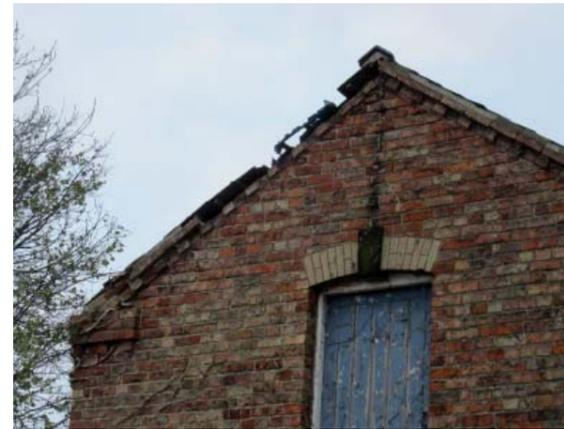
5.2

Gable: slating and undercloak missing.

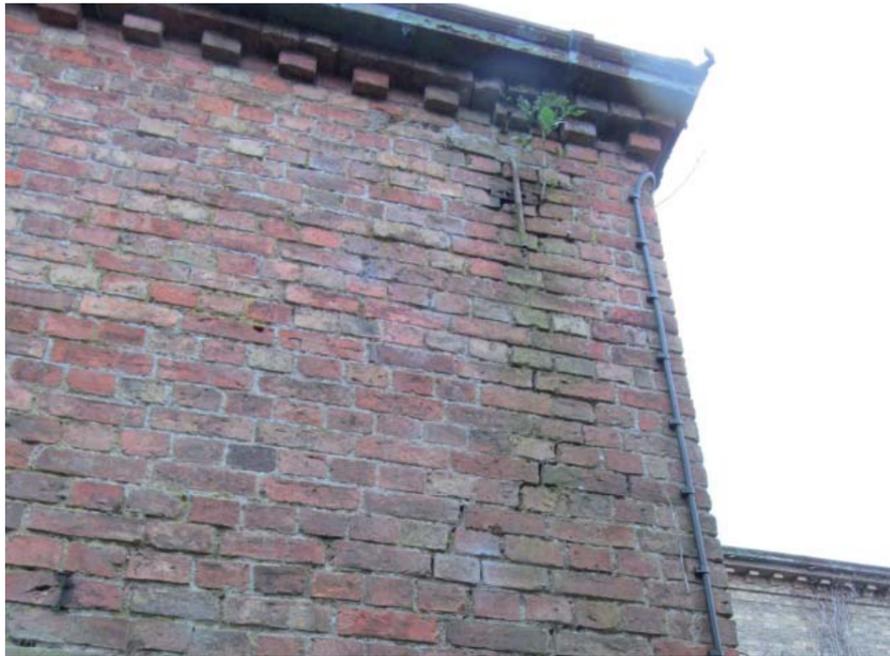
6.1

Cell block north wall: missing downpipe and erosion of pointing.

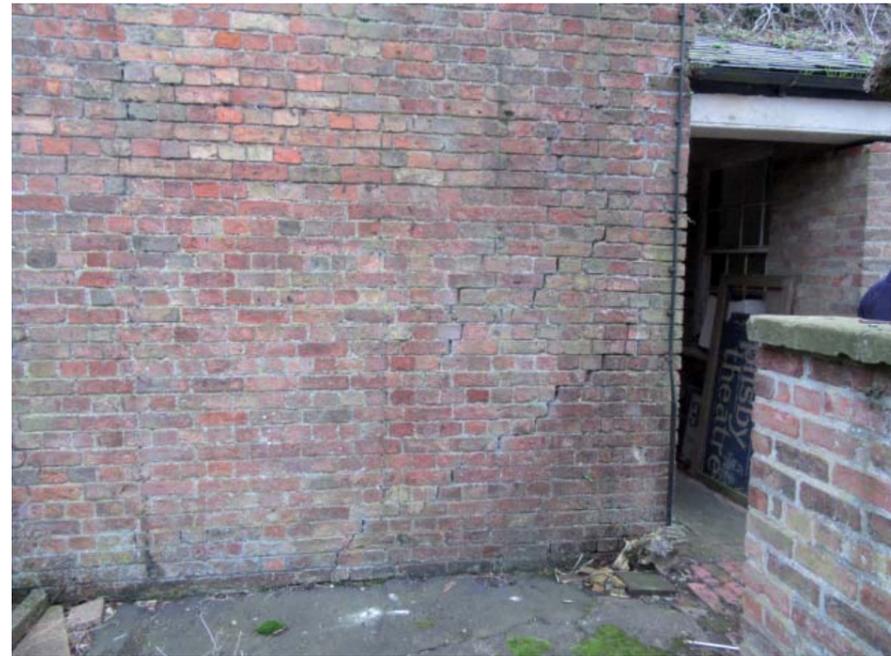
6.2

Movement and cracking in the north-west corner of the cell block. The stump or the drain to the bottom-right of the photo suggests the cause.

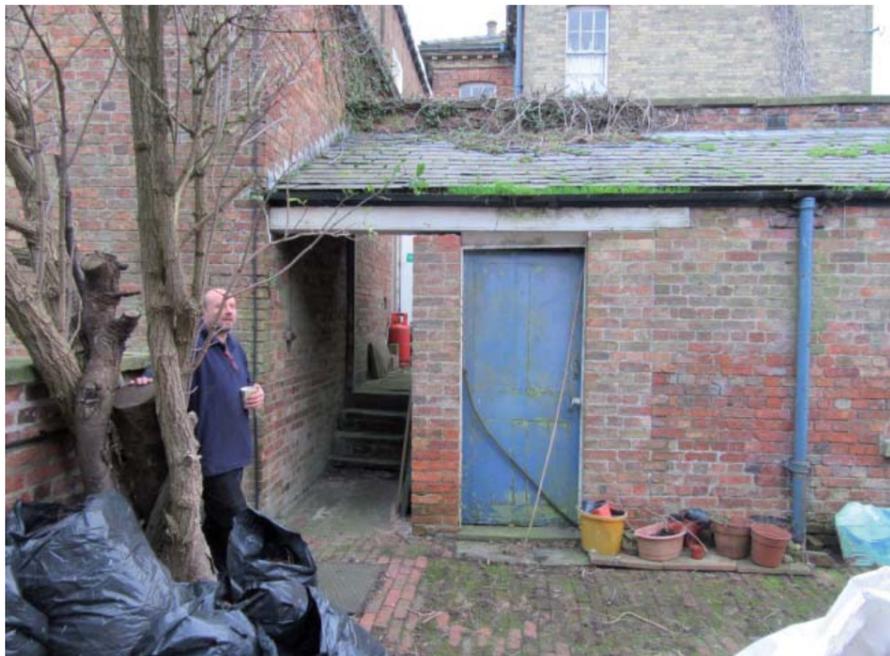
6.3

Brickwork under the white-painted beam looks to be a later in-fill which was not well founded and has moved.

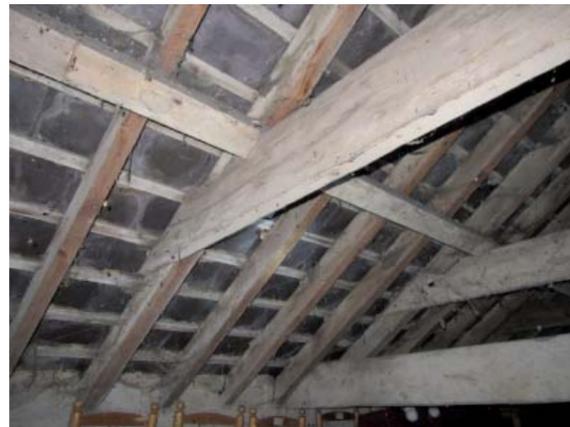
9.5 Typical wall plate, in fair condition.

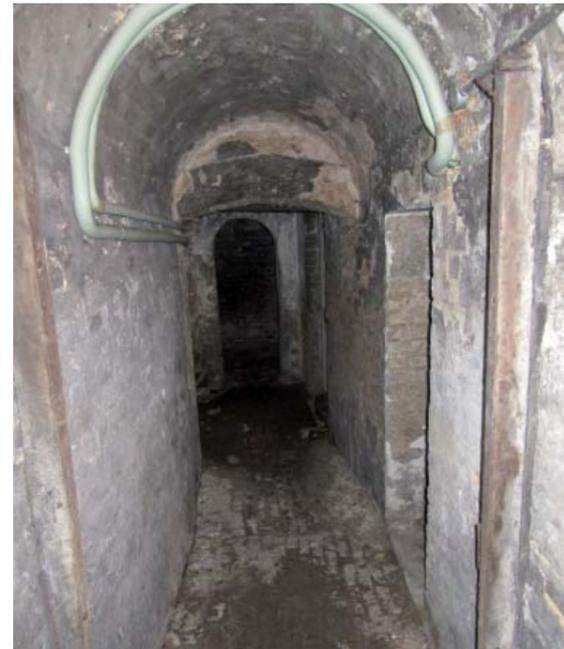
11.1

11.2
Underground prisoner's tunnel: There are no signs of structural problems. Surfaces are a little damp but there are no indications of substantial water ingress. Attempts to waterproof the area would be costly and destructive of the wonderful atmosphere. Keeping the area well ventilated is more appropriate.

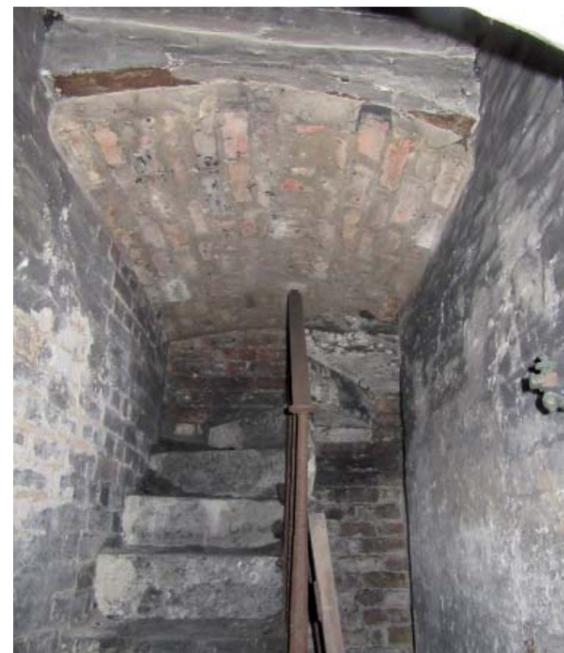
11.5
The prisoner's entrance into the middle of the courtroom from the tunnel is bricked up, possibly done in the 1870s (the stair and entrance do not appear on the 1976 plan based on the 1896 survey).

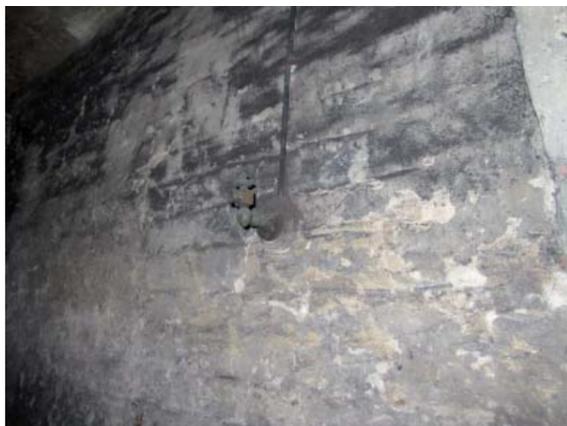
11.3
An old gas lamp fitting in the tunnel.

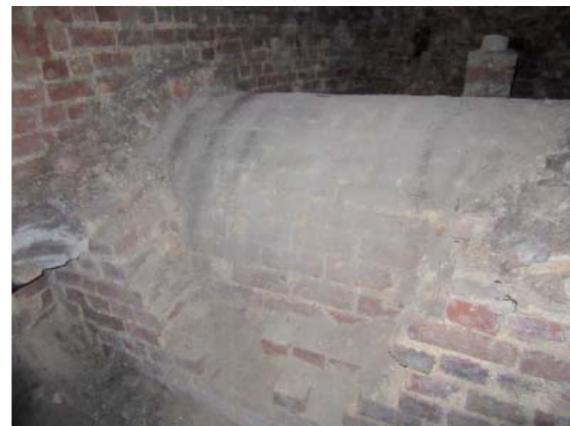
11.4
Tunnel viewed from above, from the courtroom sub-floor.

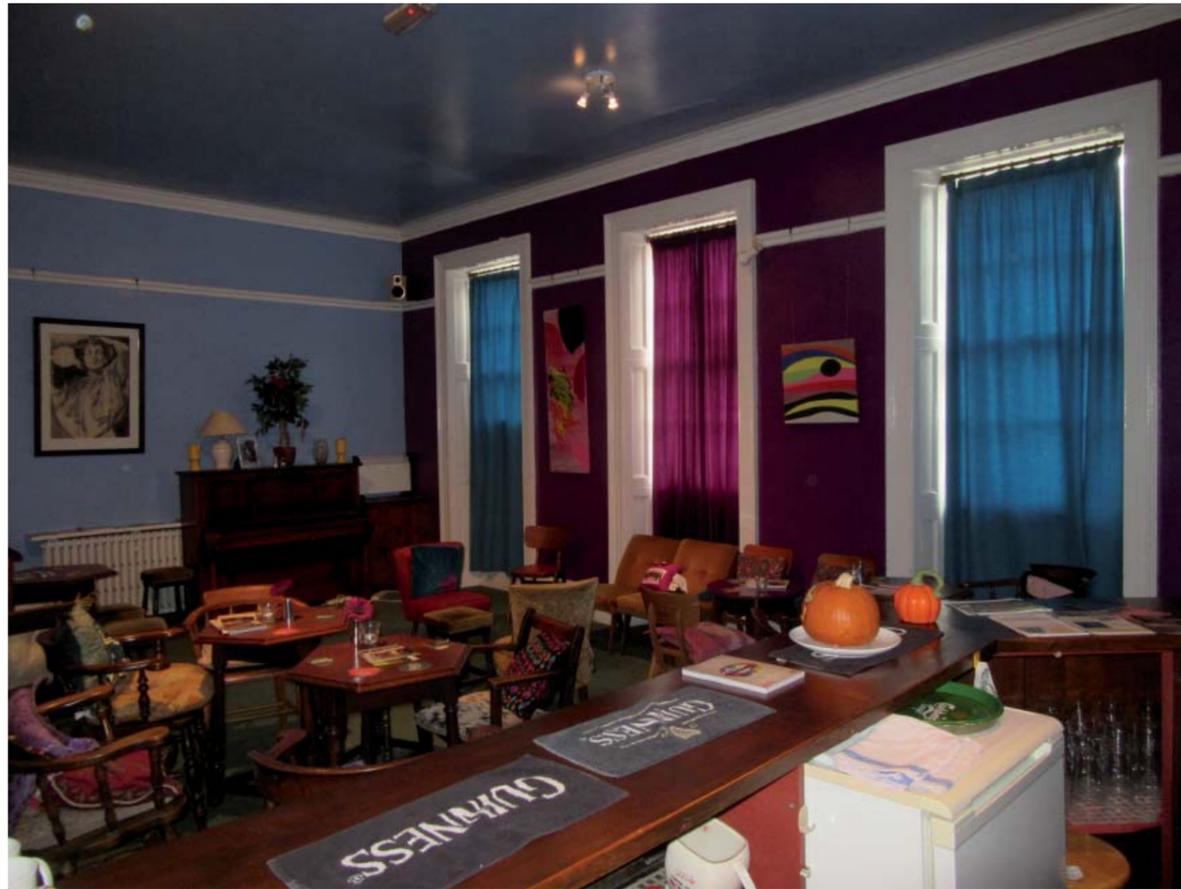
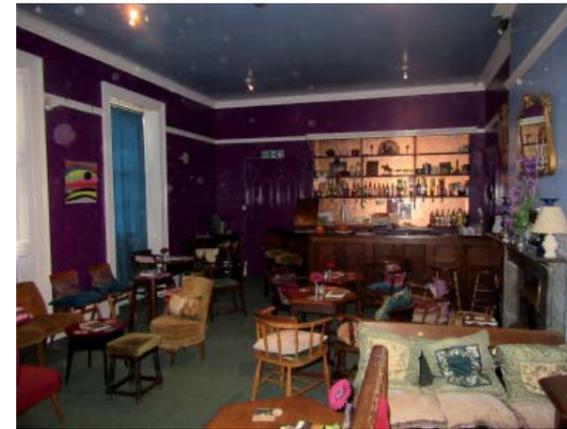
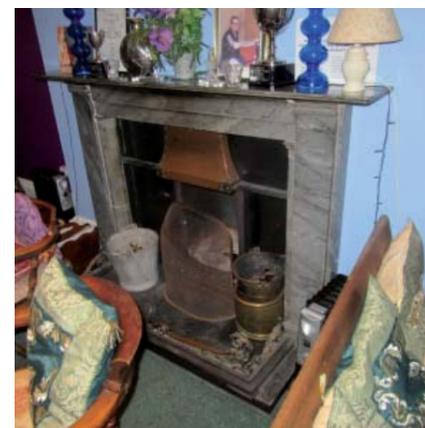
12.1, 12.2, 12.6

The former magistrate's retiring room retains its original finishes and fittings in good condition, including a fine marble fireplace.

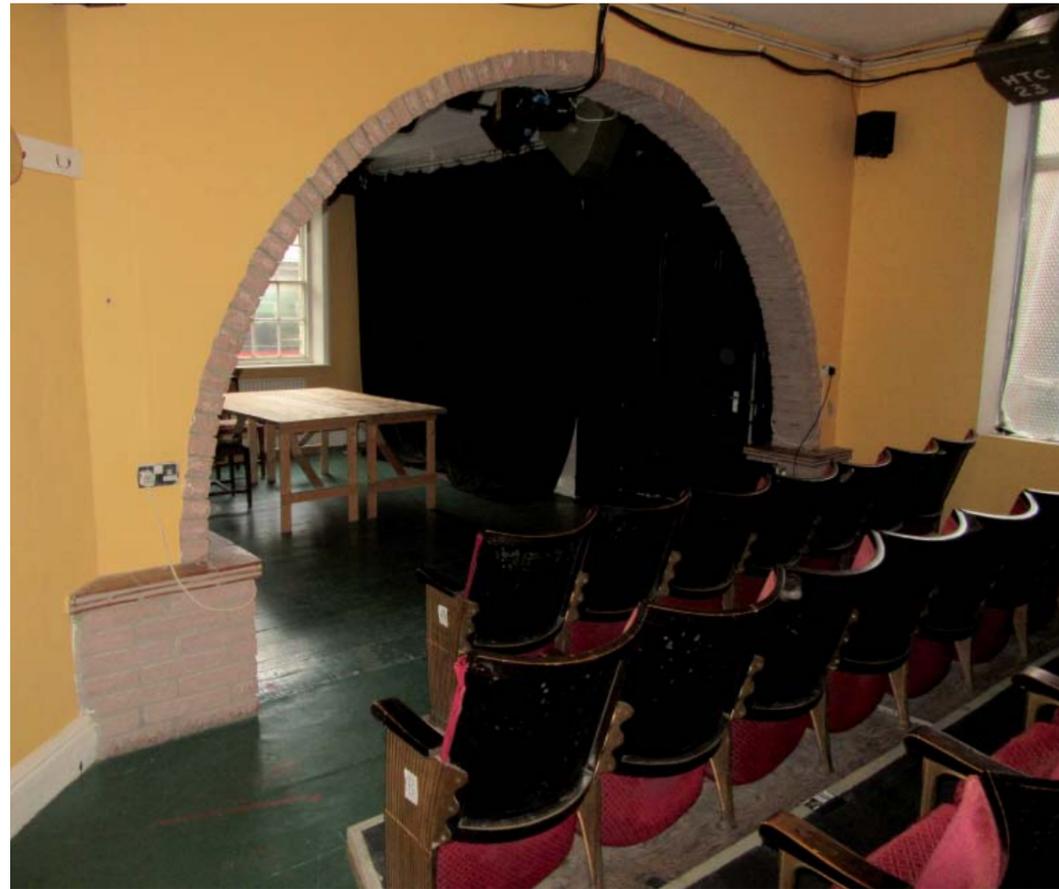
13.1

The main spaces of the police house are typical of all the rooms: finishes largely survive, in fair condition. The arch in the photo was made in the 1980s, connecting two previously separate rooms to form a tapas restaurant. The corner fireplace, to the left of the photo, is lost.

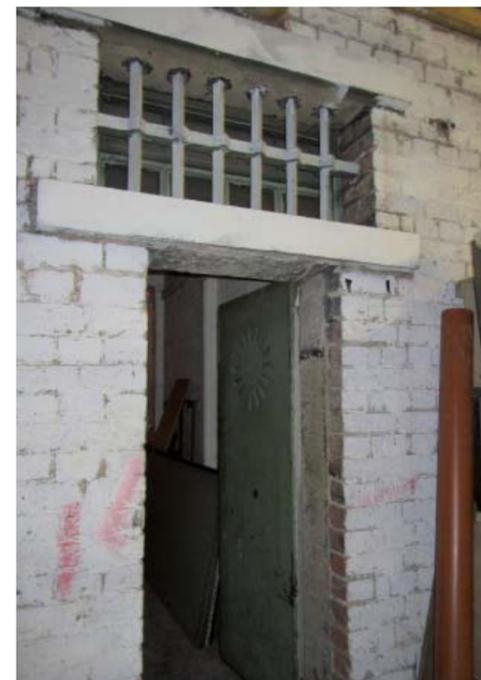
13.5

One of the cell entrances: The cast iron door, with its unusual radial grille/window that can be opened and closed and cast iron "panelling" below, has the mark of an architect about it: it is an 1820s cell door from the prison, reused in the 1870s. A number of these doors crop up in the nearby houses that were built on the site of the prison.
